**Volvo Car USA LLC****Technical Journal**

Technical Journal Title MY23+, ICUP - scratchy sound on Premium Sound Audio; AUD faults		Ref. No. TJ 36743.2.0	
Issuer (Dept.) Technical Service		Issue Date 2/1/24	Status Date 2/6/24
Car Market United States and Canada	Partner 3 US 7510 Volvo Car USA	Function Group 3900	
Function Description Media, navigation and communication		Page Page 1 of 4

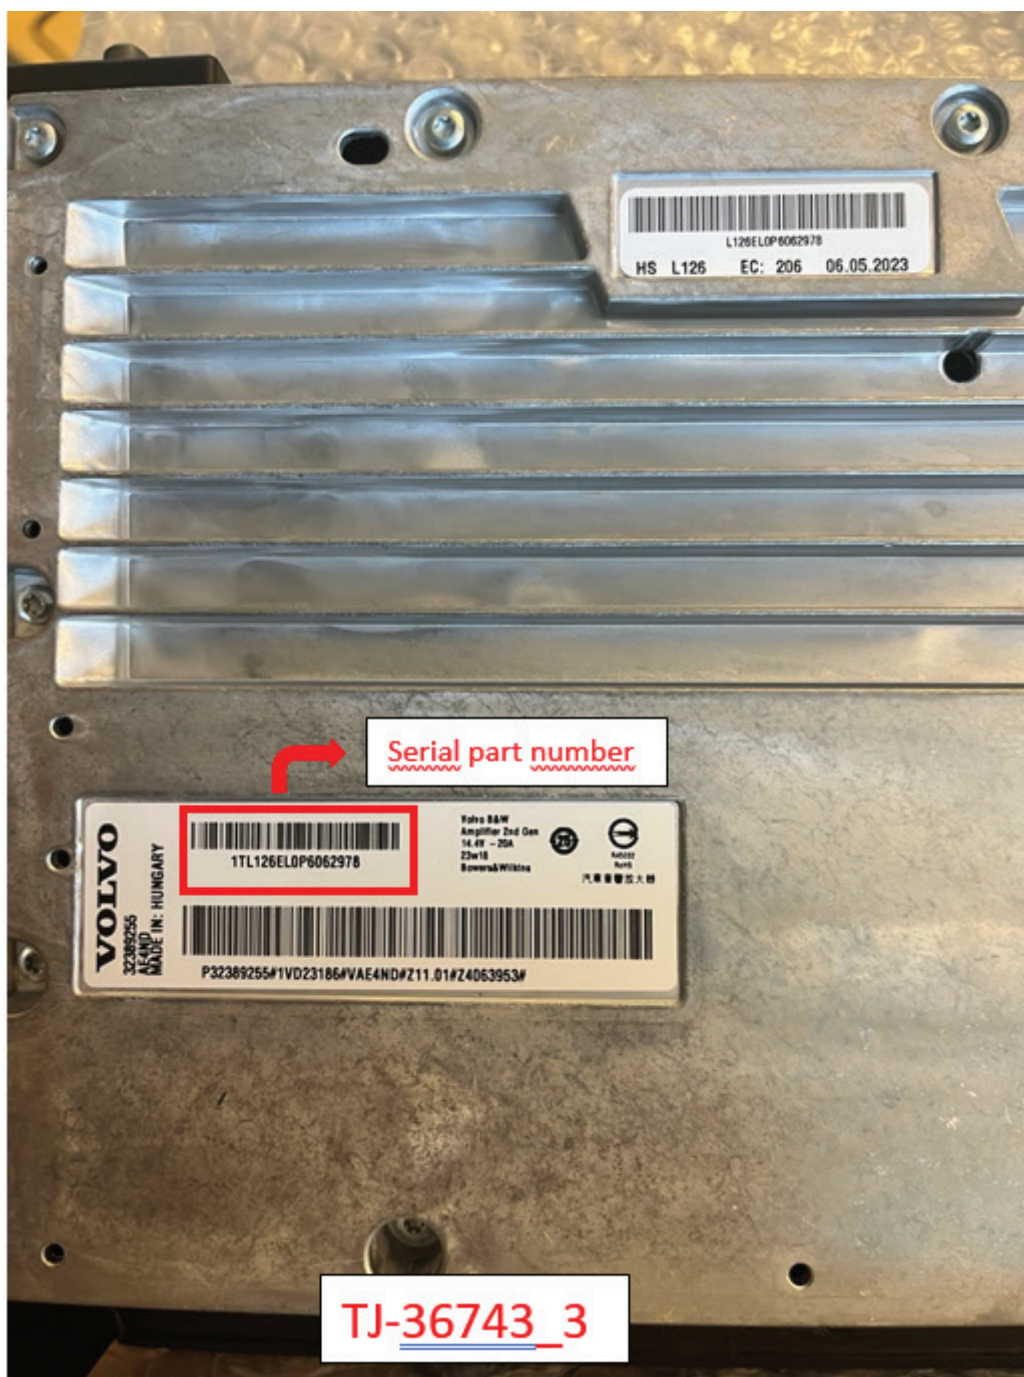
Please ensure replacement part (AUD) contains a serial number higher than 006076008
(see TJ_36743_3 for location of serial part number).

If the symptom is confirmed, the sound matches the files, and the DTCs from the list are valid, replace the AUD-unit.
