Technical product information

Topic	DTC P04F000 EVAP system high pressure purge line performance DTC logged
Market area	China 723 Volkswagen (Anhui) Automotive CO (6723),China 796 VW Import Comp. Ltd (Vico), Beijing (6796),Korea, (South) E08 Bentley South Korea (6E08),United States E05 Bentley USA and rest America (6E05)
Brand	Bentley
Transaction No.	2058573/4
Level	EH
Status	Approval
Release date

Bentayga Kovomo 4.0 TSI

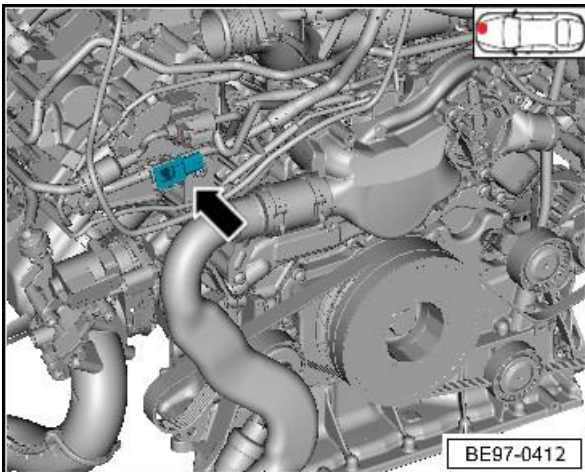
Figure 2

The DTC is related to mismatched terminal locations of the Pressure sensor for the activated charcoal filter system – G804 (Figure 2)

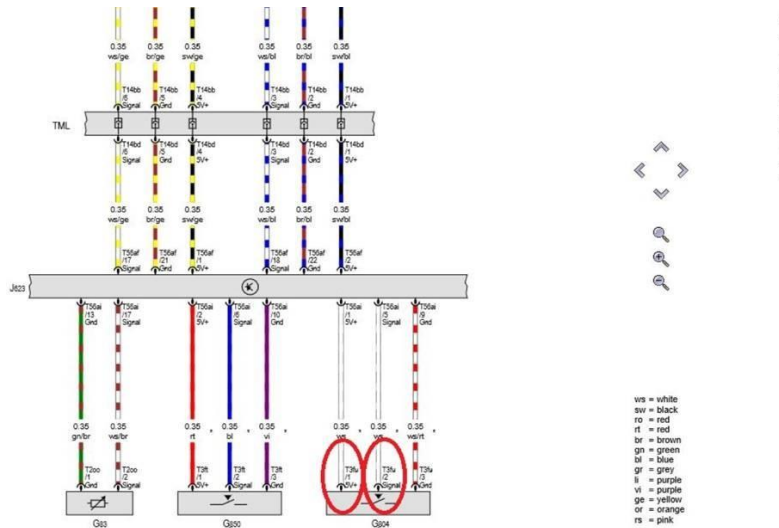
Figure 3

1) Refer to Wiring diagram 106/18 within Elsa pro (Figure 3)

2) Should the terminal locations **NOT** be as shown in Figure 3, the terminals should be reallocated within plug as per the wiring diagram

3) Gain access to the plug as follows:

- Refer to Repair manual Rep.Gr 20 - Tank ventilation pressure sensors - To remove and fit to gain access to the sensor connection
- Reallocate the sensor terminals as per Elsa pro wiring diagram instruction
