WRB6 - Replacing Gateway Control Unit (Stop Delivery)

Model Line: **Cayenne (9YA / 9YB)**

Model Year: **As of 2023 up to 2024**

Concerns: **Gateway control unit**

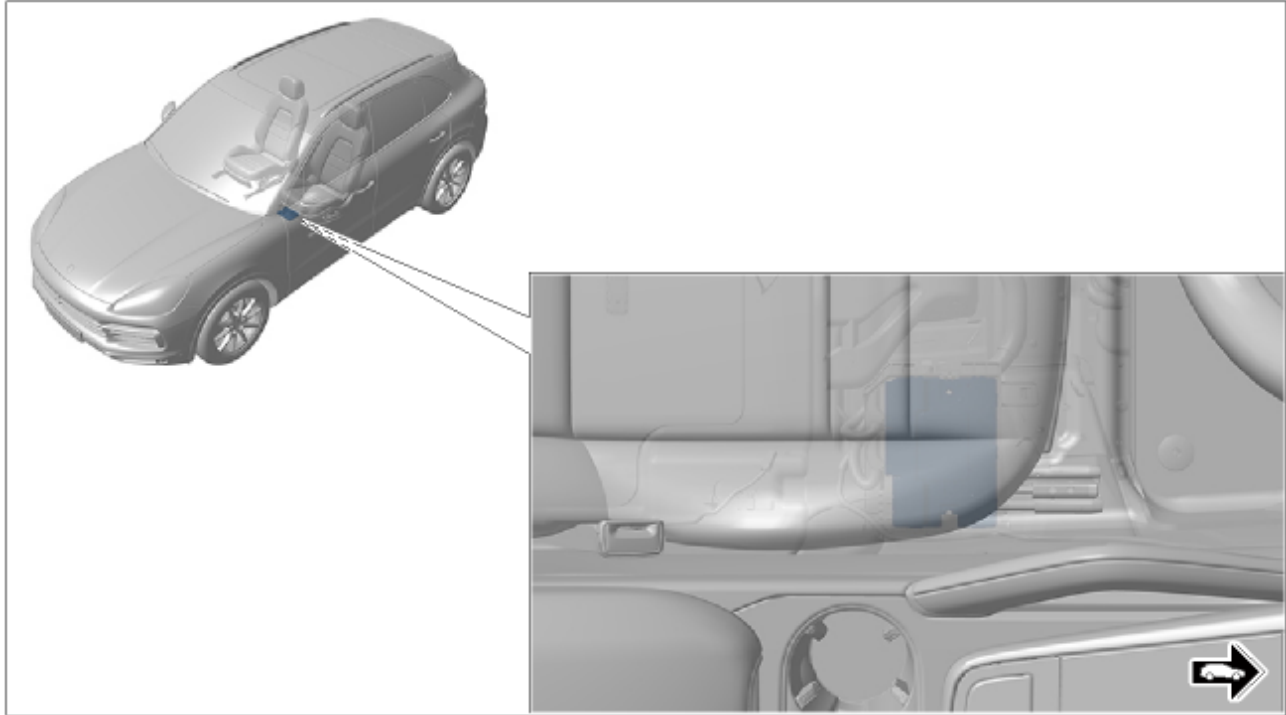
Installation position of gateway control unit

- Work Procedure: 1 Replace the gateway control unit.
 For procedure, see:
 ⇒ *Workshop Manual '903519 Removing and installing gateway control unit'*
 ⇒ *Workshop Manual '903555 Replacing gateway control unit'*
- 2 Enter the campaign in the Warranty and Maintenance logbook.
