WRB6 - Replacing Gateway Control Unit (Stop Delivery)

Model Line: **911 (992)**

Model Year: **As of 2023 up to 2024**

Concerns: **Gateway control unit**

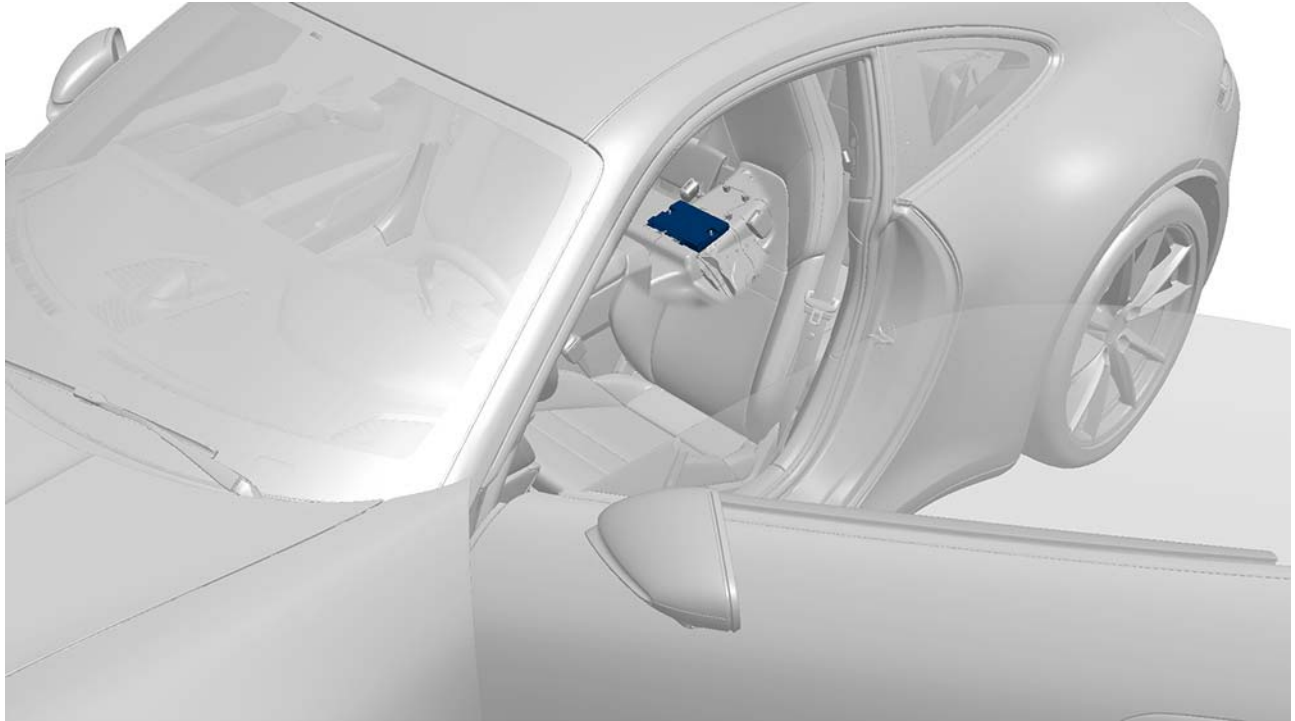
Installation position of gateway control unit

- Work Procedure: 1 Replace the gateway control unit.
 For procedure, see:
 ⇒ *Workshop Manual '903519 Removing and installing gateway control unit'*
 ⇒ *Workshop Manual '903555 Replacing gateway control unit'*
- 2 Enter the campaign in the Warranty and Maintenance logbook.
