Technical Service Bulletin

GROUP BODY ELECTRICAL	NUMBER 24-BE-002H
DATE JANUARY 2024	MODEL(S) SEE BELOW

SUBJECT: AVN SOFTWARE UPDATE FOR RADIO APP CRASH AND UNEVEN ROAD WARNING

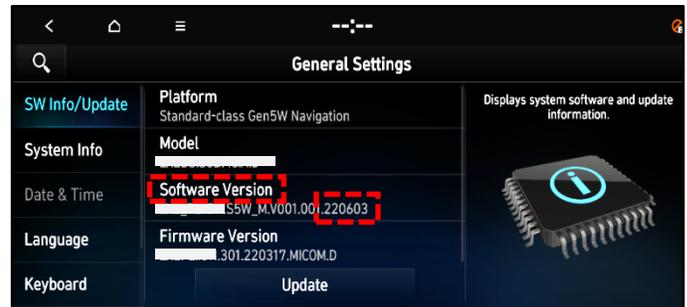
4. Check the Software Version that's currently installed.
If software version is one of the versions listed below, the AVN needs to be updated.

Current Software Version:

- 221011
- 221025
- 221115
- 221220
- 221228

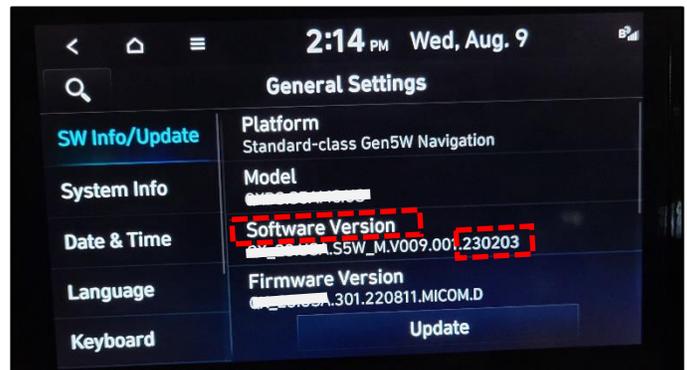
9. Confirm the S/W version has been correctly updated by referring to the 'SW Info/Update' screen.

The updated S/W version should be **230203**.
