# Technical Service Bulletin

GROUP <b>CAMPAIGN</b>	NUMBER <b>24-01-016H</b>
DATE <b>FEBRUARY 2024</b>	MODEL(S) <b>ELANTRA (AD)</b>

**SUBJECT:** IBU/BCM ANTI-THEFT SOFTWARE UPGRADE  
(SERVICE CAMPAIGN 9A8)

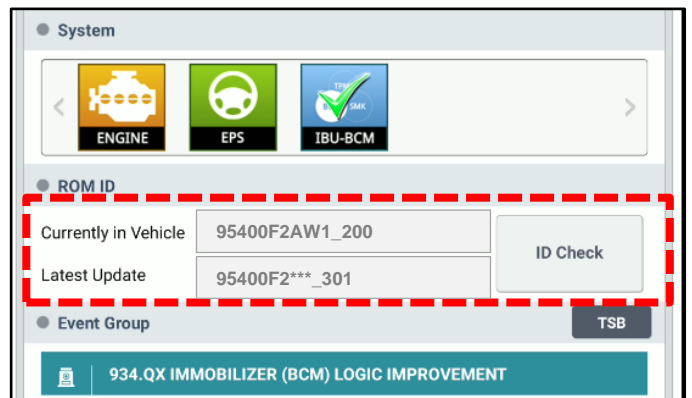
2. Select ID Check.

Check the current version of the IBU/BCM ROM ID and compare it to the ROM ID information table listed below before attempting to perform the software upgrade.

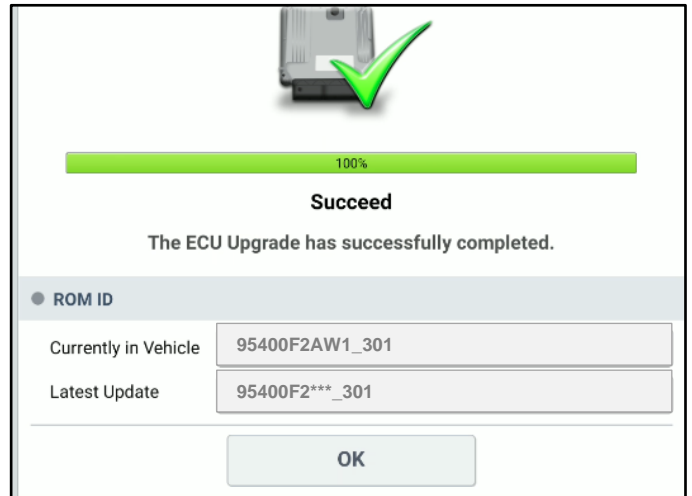
- 4. Ensure the software upgrade was successful with the latest ROM ID.

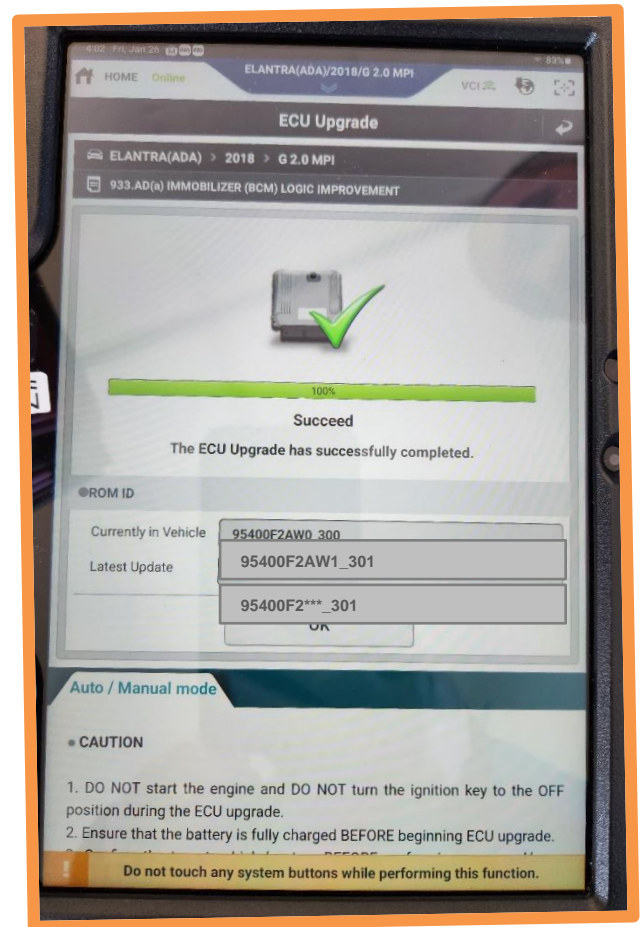
Take a screenshot of the 'ECU Upgrade Complete' screen using your tablet and upload to STUI.
