# Technical Service Bulletin

<b>GROUP</b>	<b>NUMBER</b>
<b>BODY</b>	<b>24-BD-002G</b>
<b>DATE</b>	<b>MODEL(S)</b>
<b>FEBRUARY 2024</b>	<b>GV70 (JK1A) GV70 ELECTRIFIED (JK1A EV)</b>

**SUBJECT:** EXCESSIVE WIND NOISE FROM PANORAMIC SUNROOF

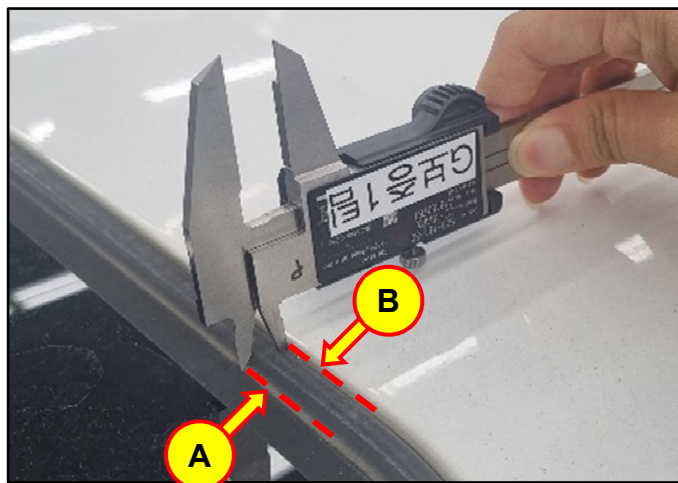
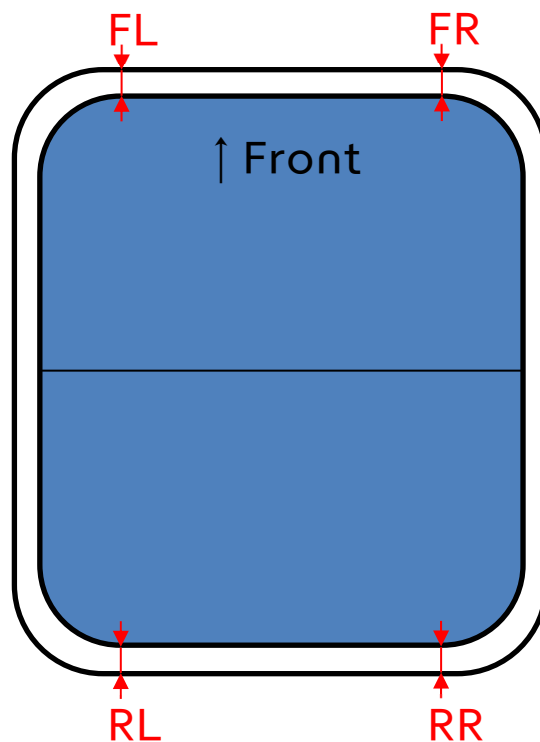
1. Using calipers, measure the distance between the edge of the sunroof glass (A) and the roof body panel (B) at the indicated locations in the diagram:

- If any of the 4 measurements are outside the specified range of 12.0 – 14.0 mm, then proceed to the next step.
- If all 4 measurements are within the specified range of 12.0 – 14.0 mm, this TSB does **NOT** apply. Please refer to the shop manual for further repair diagnosis.
