# Service Bulletin

Bulletin No.: 21-NA-186

**Subject:** Service Engine Soon Illuminated in Driver Information Center (DIC) and/or a Malfunctioning Fuel Gauge, DTC U0076/U18A2/P1001/P1434 or Other Message Counter Incorrect Codes Set

Brand:	Model:	Model Year:		VIN:		Engine:	Transmission:
		from	to	from	to		
Chevrolet	Malibu	2020	2024	—	—	1.5L (LFV)	—

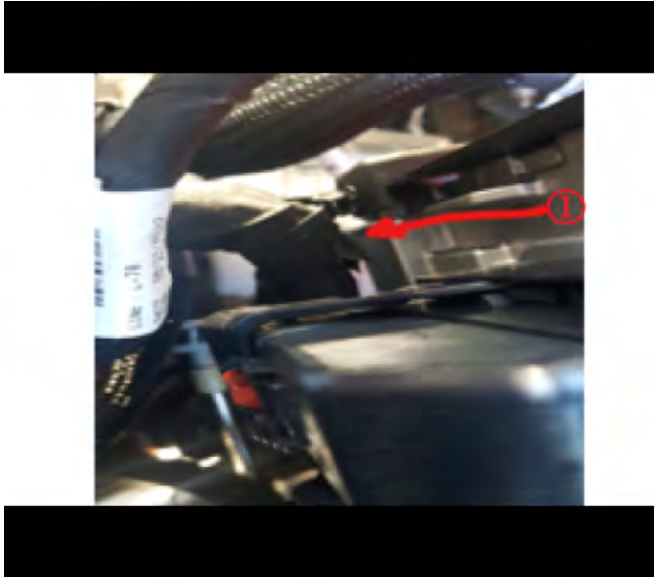
5890376

<b>Involved Region or Country</b>	North America, Israel, Palestine
<b>Condition</b>	Some customers may comment on a Service Engine Soon (SES) light and/or a malfunctioning fuel gauge. Technicians may find U0076/U18A2/P1001/P1434 or other Message Counter Incorrect codes set current or in recent history.
<b>Cause</b>	The cause of the condition may be the wire harness at the Engine Control Module (ECM) is chafing against the ECM bracket.
<b>Correction</b>	Repair the wire(s) and secure the wire harness.

1. Locate the ECM harness (1) in the engine compartment near the battery. Refer to *Engine Control Module Replacement* in SI.
