# Service Alert

Mazda North American Operations  
Irvine, CA 92618-2922

<b>Subject:</b>  16" AND 17" TIRE SIDEWALL DISTORTION	<b>Service Alert No.:</b> SA-014/24
	<b>Last Issued :</b> 02/16/2024

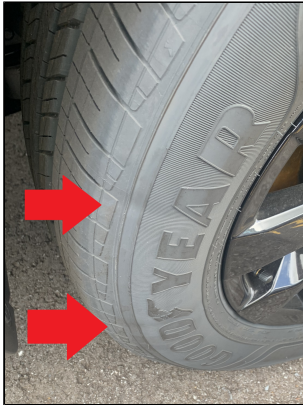
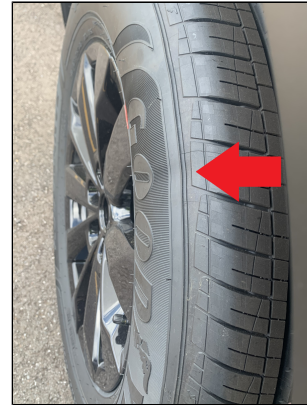
### Sidewall Indentations / Undulations

Sidewall waviness/indentations/undulations are common on radial tires and are more noticeable on tires with taller sidewalls. The higher the tire pressure, the more noticeable the effect will be. Be sure to set the tire pressures at the recommended tire pressure on the vehicle tire label.

Sidewall indentations are a cosmetic condition that does not affect the performance of the tires.

Tires are reinforced by multiple fabric cords encased in a thin sheet of rubber. Radial ply tires feature one or more layers of these sheets running parallel to each other from bead to bead. The sheets overlap where they meet. When the tire is mounted and inflated to operating air pressures, it is free to expand. The overlapped splices may create slight indentations since they stretch slightly less than the rest of the sheet. In reality, the splices are the most reinforced area of the tire's sidewall.

Because radial tires feature steel cord reinforcing belts under the tread to keep them smooth, indentations only appear on the sidewalls.
