Service Bulletin

Bulletin No.: 24-NA-039

Subject: Dead Battery and / or Unwanted Liftgate Opening

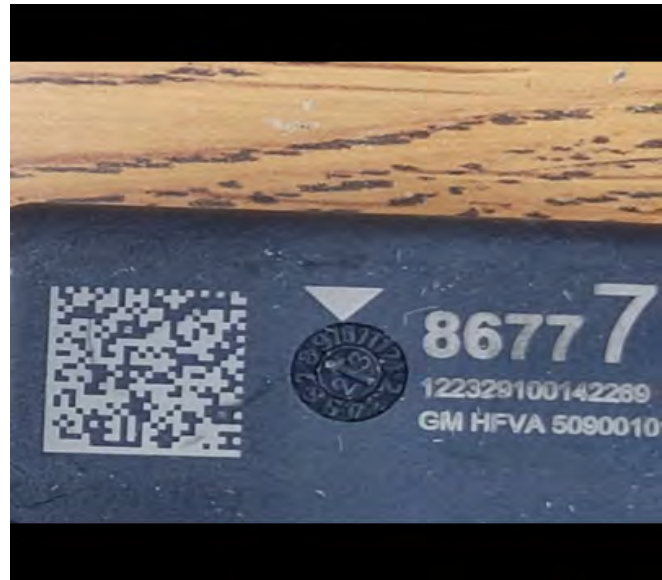
6557529

Note: Vehicles built after October 2023 have a new design K171 Hands Free Liftgate module that addresses unwanted liftgate activation and potential battery drain. Modules stamped with a triangle are the new design. With this change, the bulletin is approved.

In the meantime, make sure the BCM has the latest programming updates. Advise the customer not to leave the key fob(s) inside the vehicle and to also lock the vehicle when not in use. Turning on the passive locking feature will ensure the vehicle is being locked when not in use. Last, if the customers complaint included the power liftgate opening on its own or the source of the vehicle waking up/battery draw is the K171 Hands Free Liftgate module then replace the K171. One way to help determine if the K171 is waking up the vehicle is to remove the F35RA 10 amp in the rear fuse block for the K171 and see if the concerns go away.

As a test to determine if the K171 Hands Free Liftgate module is causing the battery draw or if replacing the K171 Hands Free Liftgate module and it is not available/back order, the F35RA fuse can be left removed while the customer takes the vehicle. With the fuse removed, the hands free liftgate feature will not work, but the power liftgate will still function normally. In addition, if the truck is equipped with Trailer Tire Pressure Monitor system (RPO UET), then that feature will also be lost while the fuse is pulled. Please review this option with the customer if the K171 Hands Free Liftgate module is not readily available or for testing.
