# TECHNICAL SERVICE BULLETIN

## Water Entry Into The Rear Trunk Area - Built On Or Before 28-Feb-2023

**24-2032**

<b>Ford</b> 2021-2023 Bronco	Built on or before 28-Feb-2023
---------------------------------	--------------------------------

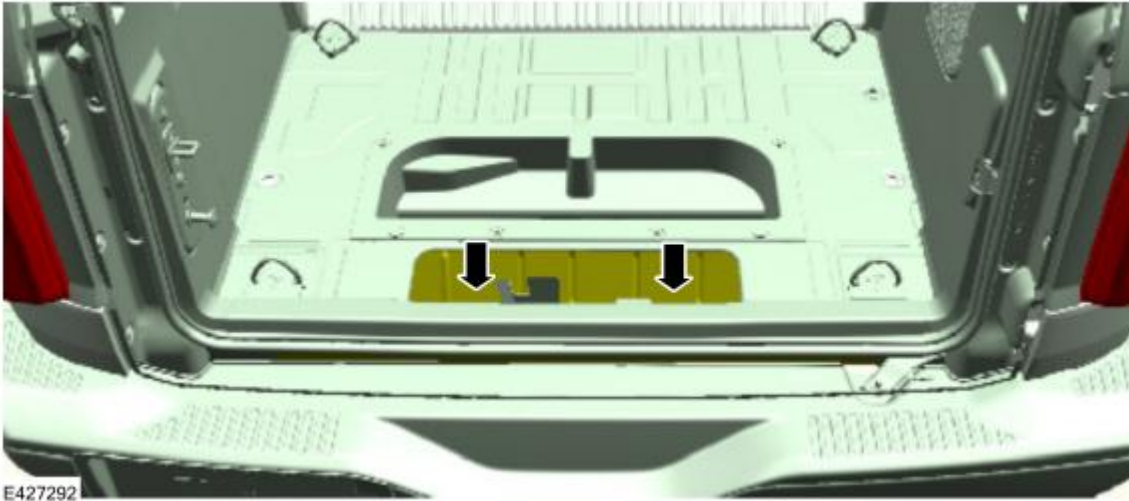
Figure 1

1. Inspect the rear trunk area highlighted in Figure 1.

2. Is water present only in the area highlighted in Figure 1?

3. Remove the jack and tool kit from the rear trunk area. (Figure 1) Refer to the Owner's Manual > Changing A Road Wheel-Changing A Flat Tire.
