TECHNICAL SERVICE BULLETIN

Equipped With Minor Feature Code HUKAJ - 400 Watt DC/AC Inverter System Inoperative With B1330:9A In The BCM

24-2039

Ford 2021-2023 F-150

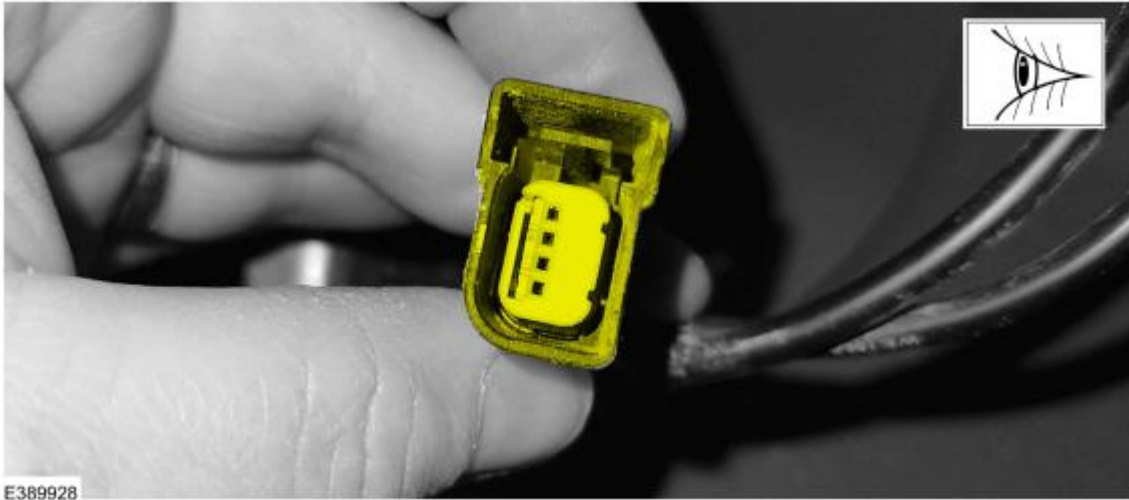
Figure 2

3. Inspect connector C4628 for the presence of corrosion, dirt and/or damage. Is corrosion, dirt and/or damage present in connector C4628? (Figure 2)

- (1). Yes - replace the pickup bed AC power outlet socket assembly. Refer to WSM, Section 414-05. Replace the body side harness assembly (13A409) of connector C4628. Proceed to Step 4.
 - (2). No - proceed to Step 4.
4. Install a new pickup bed AC power outlet socket harness retainer 4.3 in. (110 mm) from the back of the pickup bed power outlet harness connector. If the pickup bed AC power outlet socket has been replaced, remove and discard the factory-installed harness retainer and install the new harness retainer. (Figure 3)

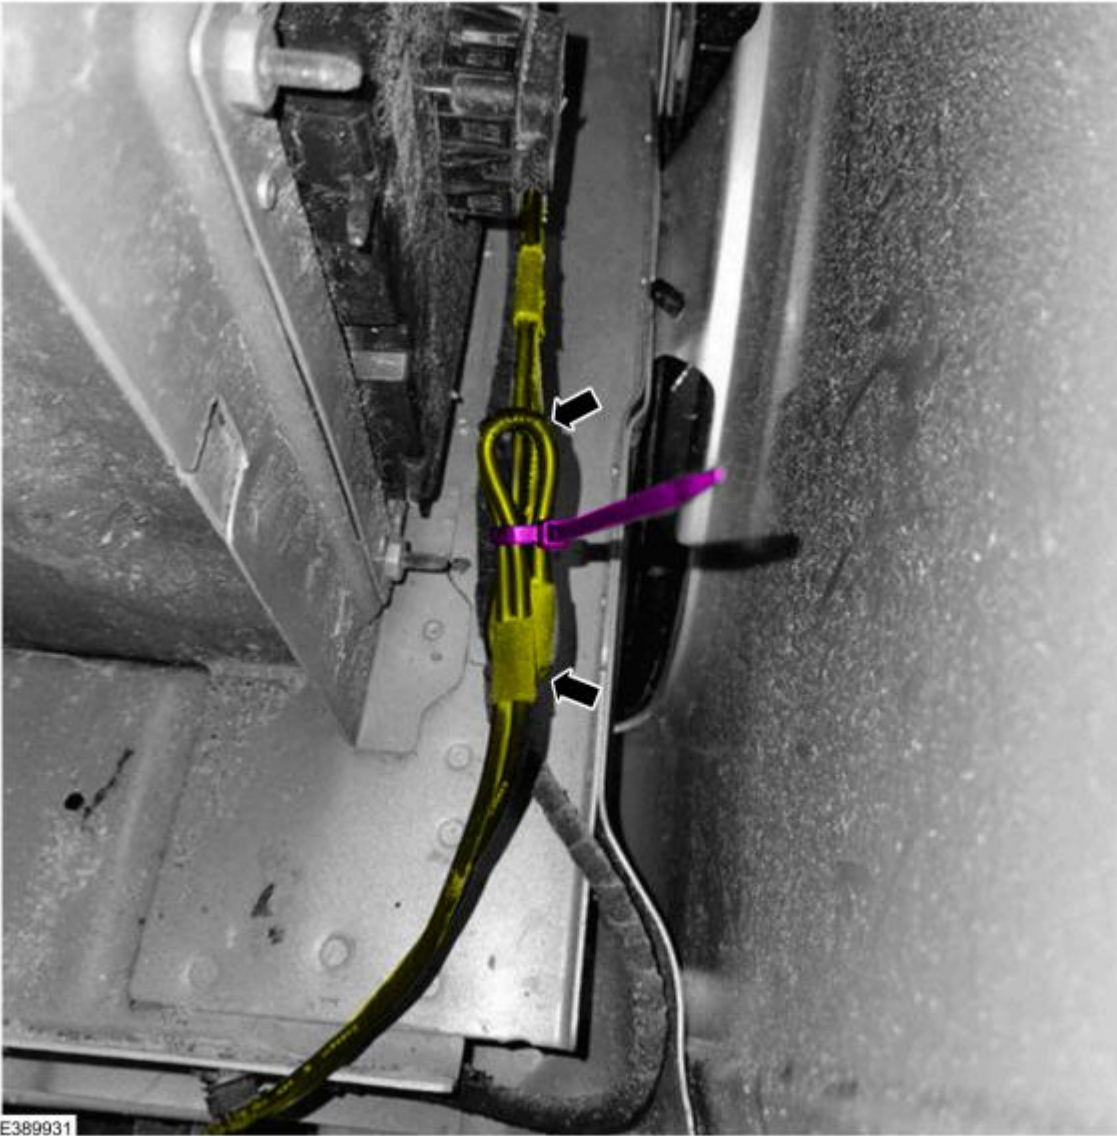
Figure 5

⚠ CAUTION: The bend radius of the pickup bed AC power outlet socket harness should be no less than 4 mm. Hard kinks and tight bends of the pickup bed AC power outlet socket harness can lead to wire damage.

6. Fold approximately 7 in. (185 mm) of the remaining/loose pickup bed AC power outlet socket harness in 2 bends just behind the pickup bed AC power outlet socket panel. Secure the folded wire with a wire tie. Inspect the routing of the harness to make sure it is not pulled too tight against the body sheet metal near the harness retainer and provides just enough length. (Figure 5)
