TECHNICAL SERVICE BULLETIN

Non-Hybrid - Radio Static And/Or Poor Radio Sound Quality When Moving

24-2043

Ford 2020-2024 Explorer
Lincoln 2020-2024 Aviator

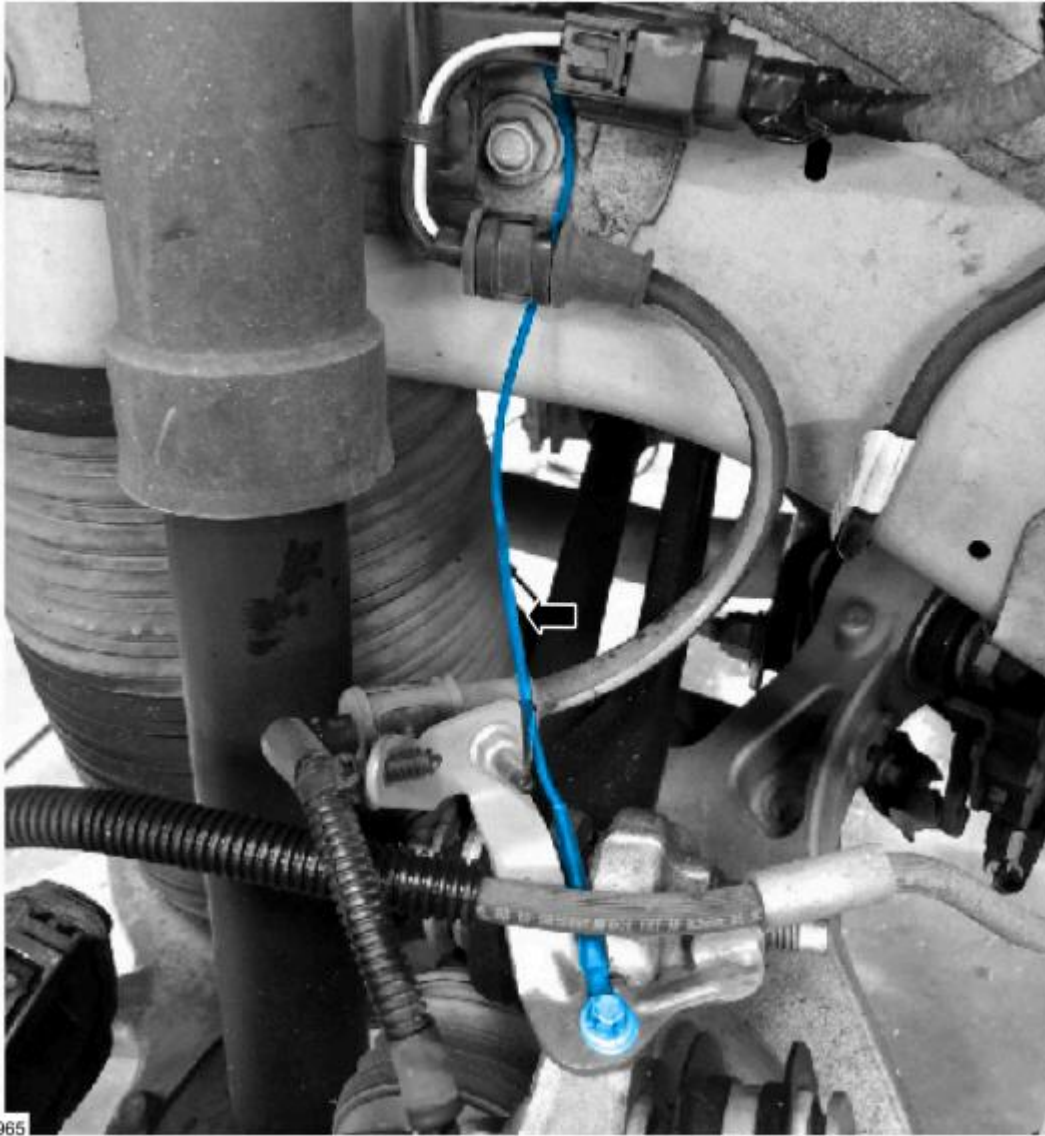
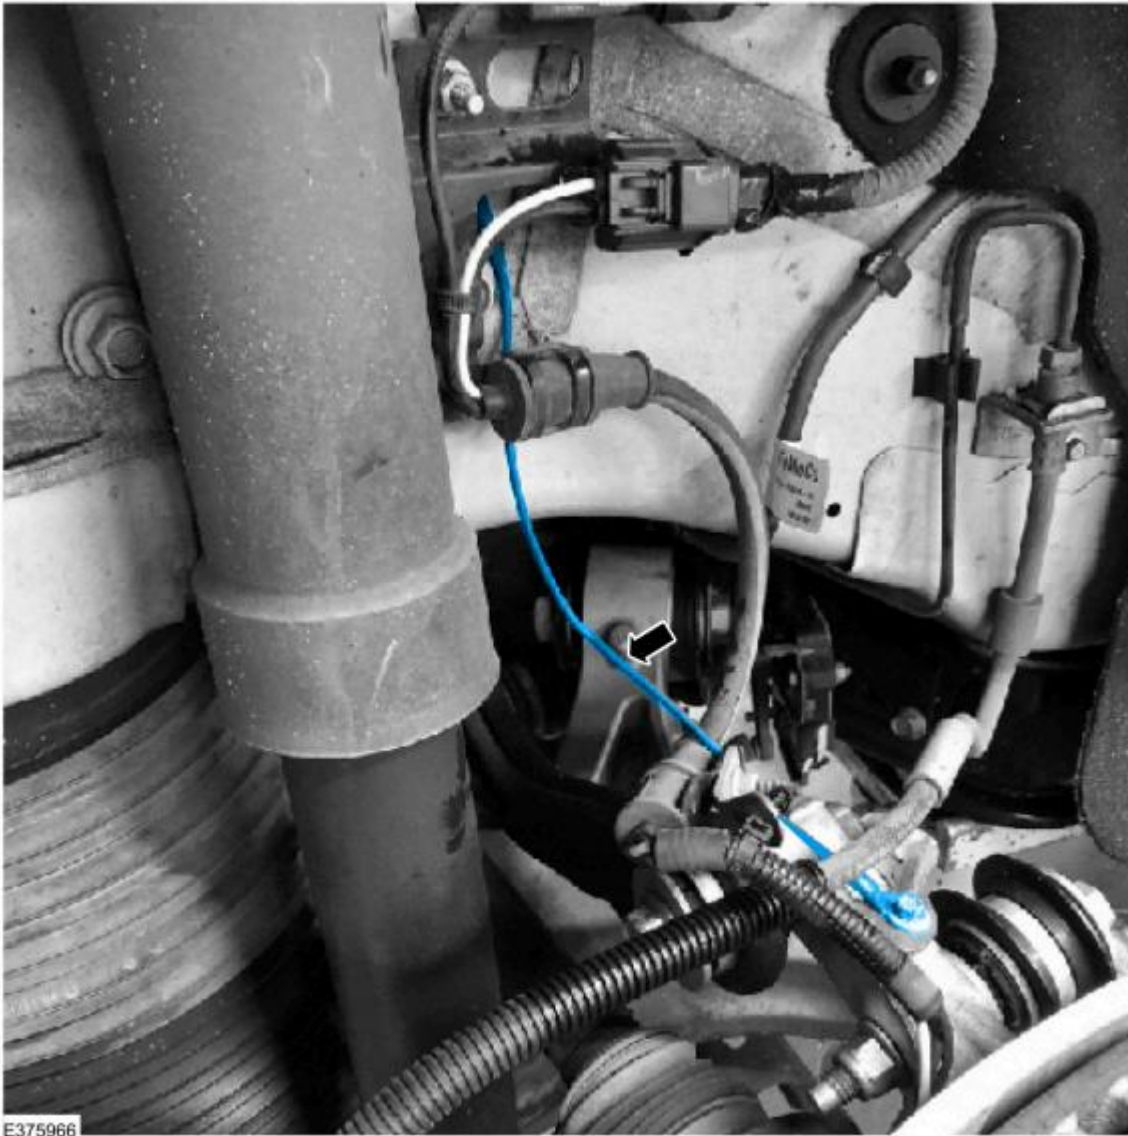
Issue: Some 2020-2024 Explorer/Aviator non-hybrid vehicles may exhibit radio static and/or poor radio sound quality when moving. This may be more noticeable on AM radio stations. This may be caused by an electromagnetic interference concern. To correct the condition, follow the Service Procedure to install new grounds on the rear knuckle.

1. Install new ground straps on each side of the vehicle on top of the brake hose bracket bolt on the rear knuckle. Tighten to 133 lb-in (15 Nm). Refer to Workshop Manual (WSM), Section 204-02. (Figure 1-2)

2. Install the other side of the ground straps underneath the rear wheel speed sensor harness bracket mounting stud. Tighten to 62 lb-in (7 Nm). Refer to WSM, Section 206-09. (Figure 1-2)
