TECHNICAL SERVICE BULLETIN

Lack Of Audio And/Or Water Leak In Rear Of Vehicle And/Or Spare Tire Area

24-2044

Ford 2020-2024 Explorer
Lincoln 2020-2024 Aviator

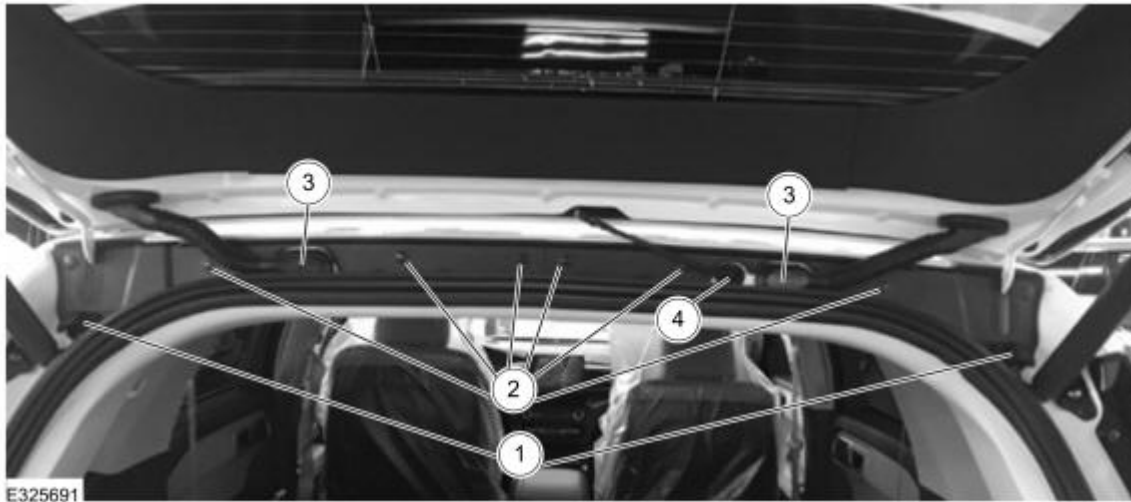
Figure 1

Item	Description
1	Power liftgate grommet (if equipped)
2	Margin seal and margin seal pushpins
3	Electrical wiring grommet
4	Rear washer hose

1. Open the rear liftgate.
2. Inspect and make sure the following components are correctly seated by pushing:
 - (1). Power liftgate grommet (if equipped). If not properly seated, replace the affected power liftgate strut. (Figure 1 Callout 1, Figure 2)
 - (2). Margin seal and margin seal pushpins. (Figure 1 Callout 2, Figure 3 Callout 2)
 - (3). Electrical wiring grommet. (Figure 1 Callout 3, Figure 3 Callout 3)
 - (4). Rear washer hose. (Figure 1 Callout 4, Figure 3 Callout 4)

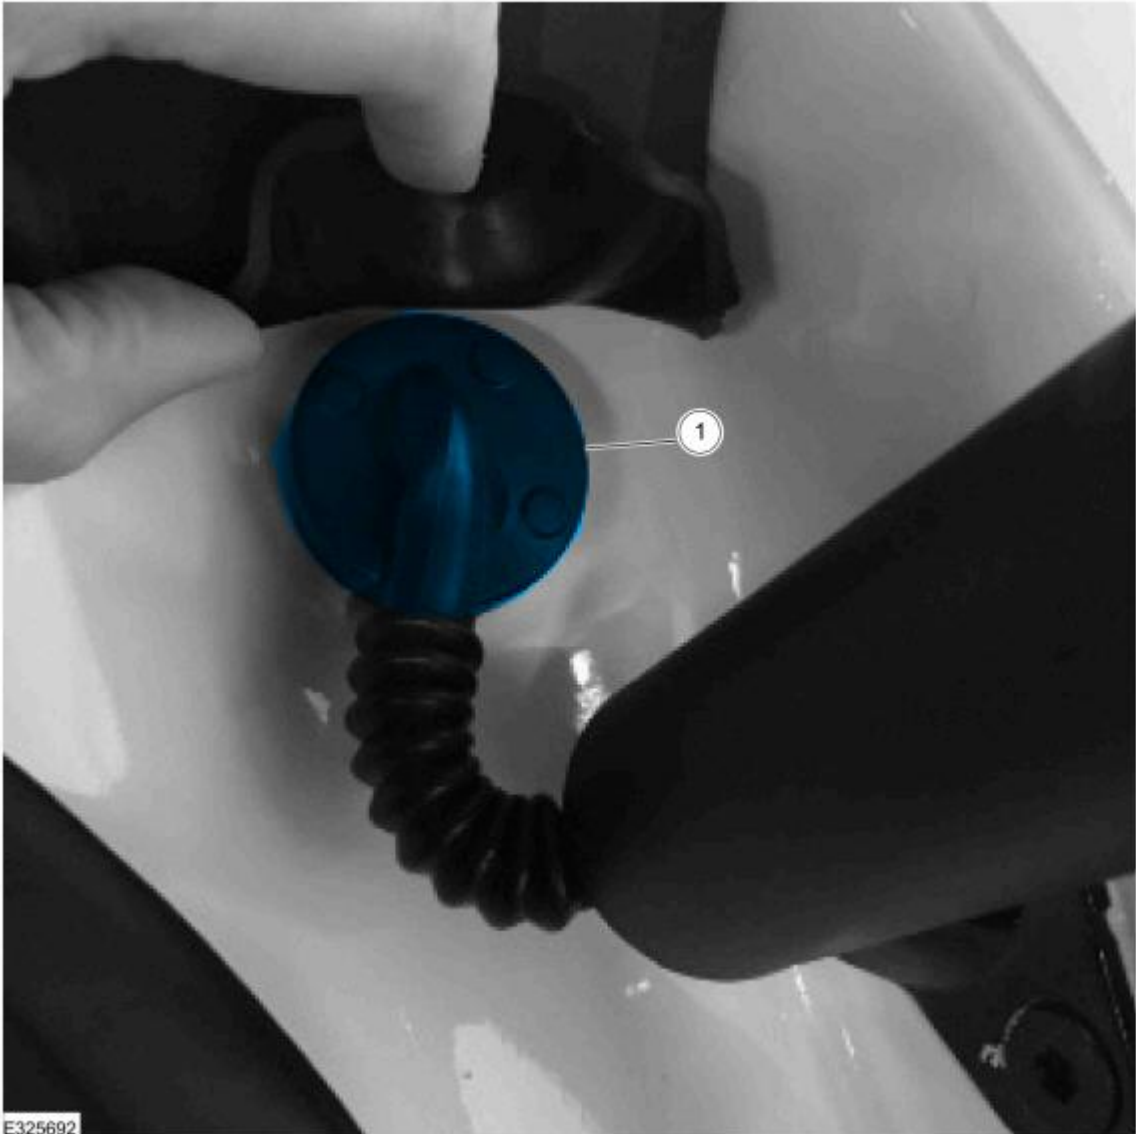
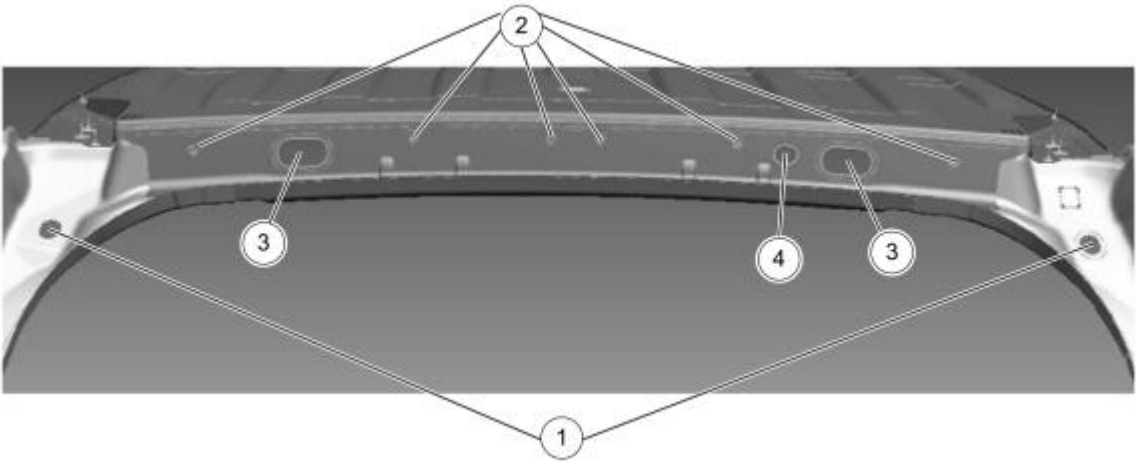
Figure 2

Item	Description
1	Power liftgate grommet
2	Margin seal and margin seal pushpins

3	Electrical wiring grommet
4	Rear washer hose

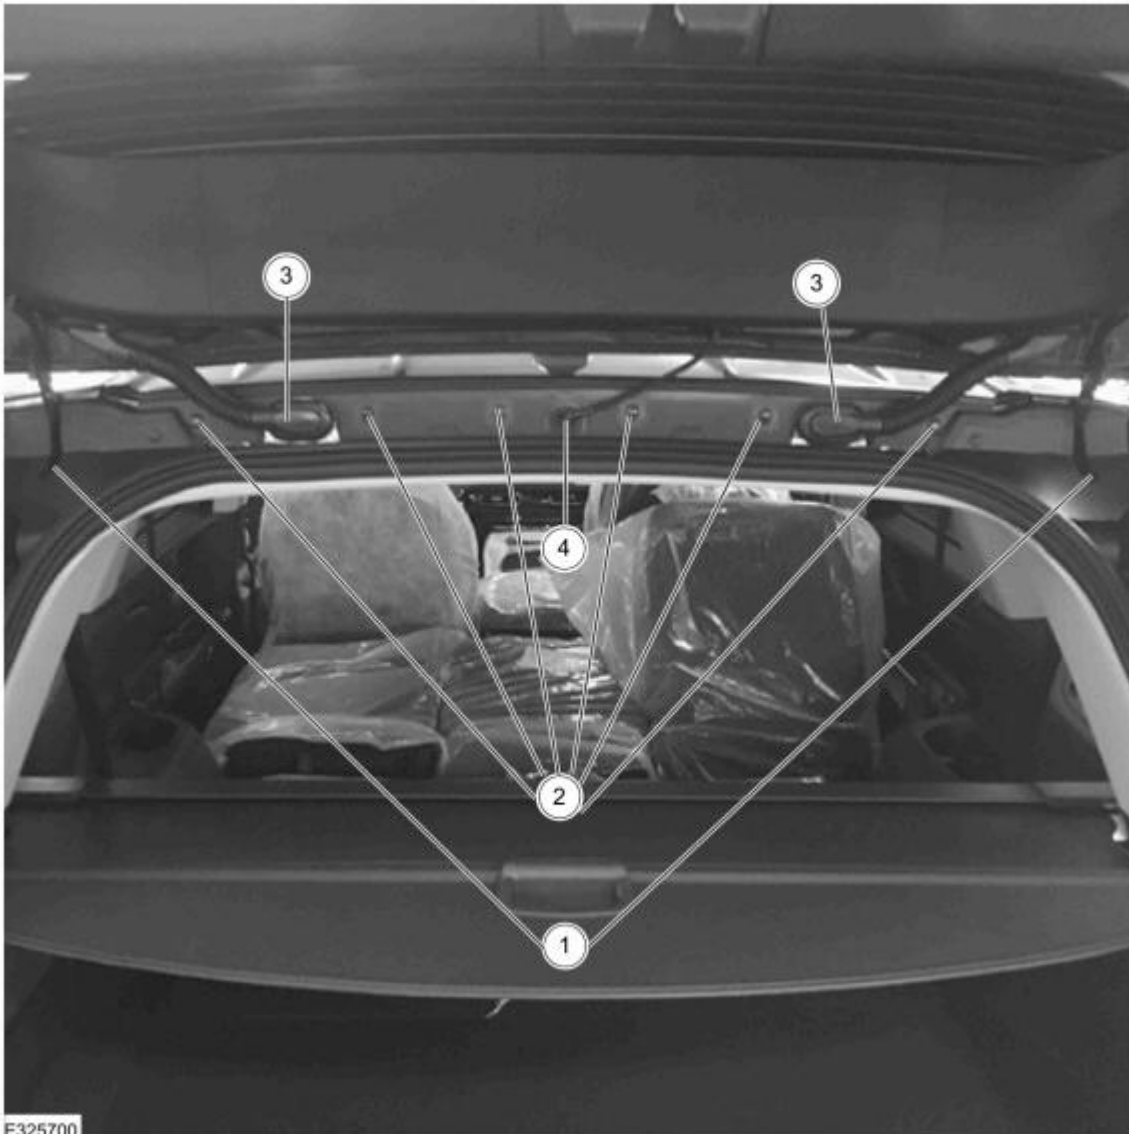
Figure 10

Item	Description
1	Power liftgate grommet
2	Margin seal and margin seal pushpins
3	Electrical wiring grommet
4	Rear washer hose

1. Open the rear liftgate.
2. Inspect and make sure the following components are correctly seated by pushing:
 - (1). Power liftgate grommet. If not properly seated, replace the affected power liftgate strut. (Figure 10 Callout 1, Figure 11)
 - (2). Margin seal and margin seal pushpins. (Figure 10 Callout 2)
 - (3). Electrical wiring grommet. (Figure 10 Callout 3)
 - (4). Rear washer hose. (Figure 10 Callout 4)
