Technical Service Bulletin

27 Repair Authorization - MY 24 BSG, Electrical Warning, DTC U046900 + B200096

27 24 67 2072960/2 March 5, 2024. Supersedes Technical Service Bulletin Group 27 number 24-66 dated February 9, 2024 for reasons listed below.

Model(s)	Year	VIN Range	Vehicle-Specific Equipment
A6, A6 allroad, S6, RS 6, A7, S7, RS 7, A8, S8, Q7, SQ7, Q8, SQ8, and RS Q8	2024	All	Battery Starter Generator

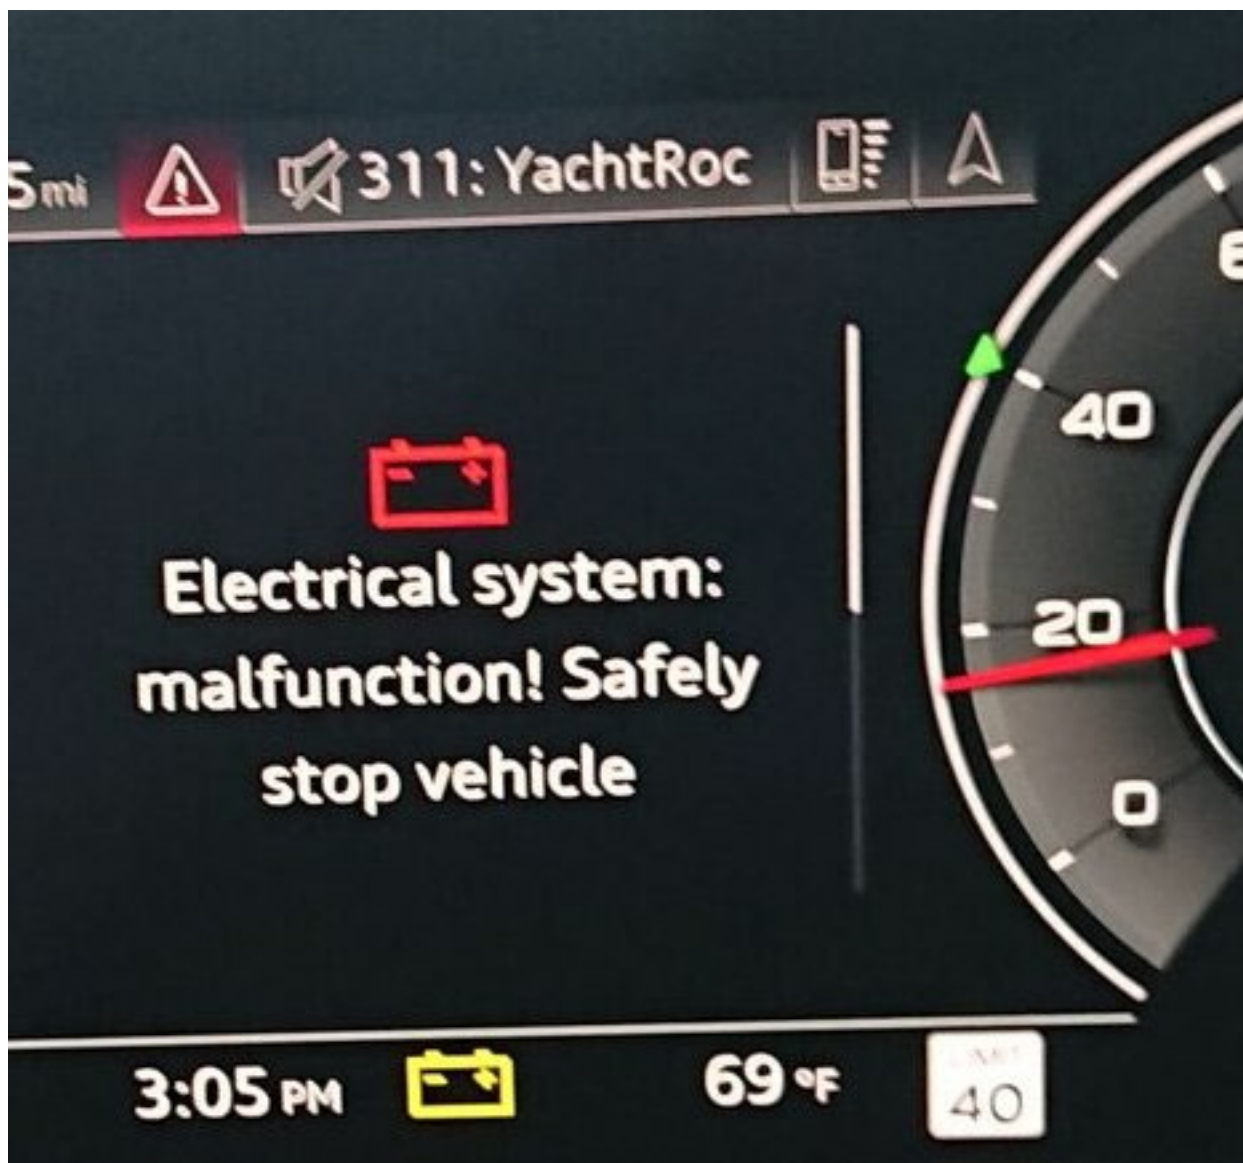
A yellow or red Electrical Supply warning is displayed in the instrument cluster.

Figure 1: Cluster Warning Message.

- Verify the condition and document with images of the cluster.
- Identify the hardware part number in diagnostic address CC. Identify if the part number is either 4N1.903.028, 4N1.903.028.B or 4N0.903.028.S.
- If the vehicle is within the New Vehicle Limited Warranty, contact a TAC consultant before proceeding. Please attach the DTC, diagnostic log with the test plan faults performed, and picture of the warning displayed in the cluster as shown in **Figure 1** to the TAC ticket.
