Technical product information

Topic	The Netflix application cannot be updated within the (BYOC) rear seat entertainment system
Market area	Australia E04 Bentley rest Asia and Australia (6E04),China 796 VW Import Comp. Ltd (Vico), Beijing (6796),Germany E02 Bentley rest Europe (6E02),Japan E03 Bentley Japan (6E03),Korea, (South) E08 Bentley South Korea (6E08),United Arab Emirates E06 Bentley Middle East and Africa (6E06),United Kingdom E01 Bentley UK (6E01),United States E05 Bentley USA and rest America (6E05)
Brand	Bentley
Transaction No.	2073021/1
Level	EH
Status	Approval
Release date

New Flying Spur Series and Bentayga Series

The Netflix application cannot be updated within the (BYOC) rear seat entertainment system

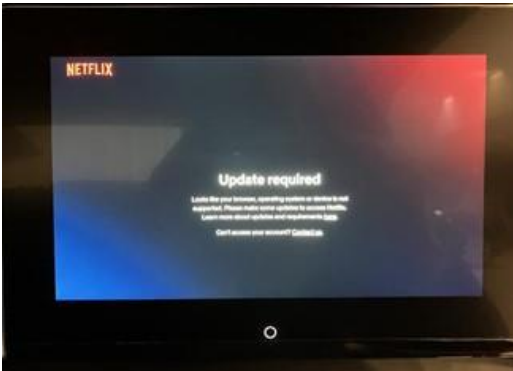
Figure 1

Netflix application update prompt is shown within the (BYOC) rear seat entertainment system (Figure 1)

In the event the issue described is evident the operative should conduct the instructions within the Measure section

- 1) Navigate to the Aftersales Section of the Bentley Hub
- 2) Search for Zip file - BYOC-Bentley-OTA-32bit_chromium_H_R12
- 3) Upload the Zip files shown in Figure 2 to a suitable USB-C stick
