Technical Service Bulletin

13 Starter/generator drive belt is noisy or came off, DTC P2BA300 may be stored in the ECM

13 24 24 2061461/9 March 8, 2024. Supersedes Technical Service Bulletin Group 13 number 23-20 dated October 13, 2023 for reasons listed below.

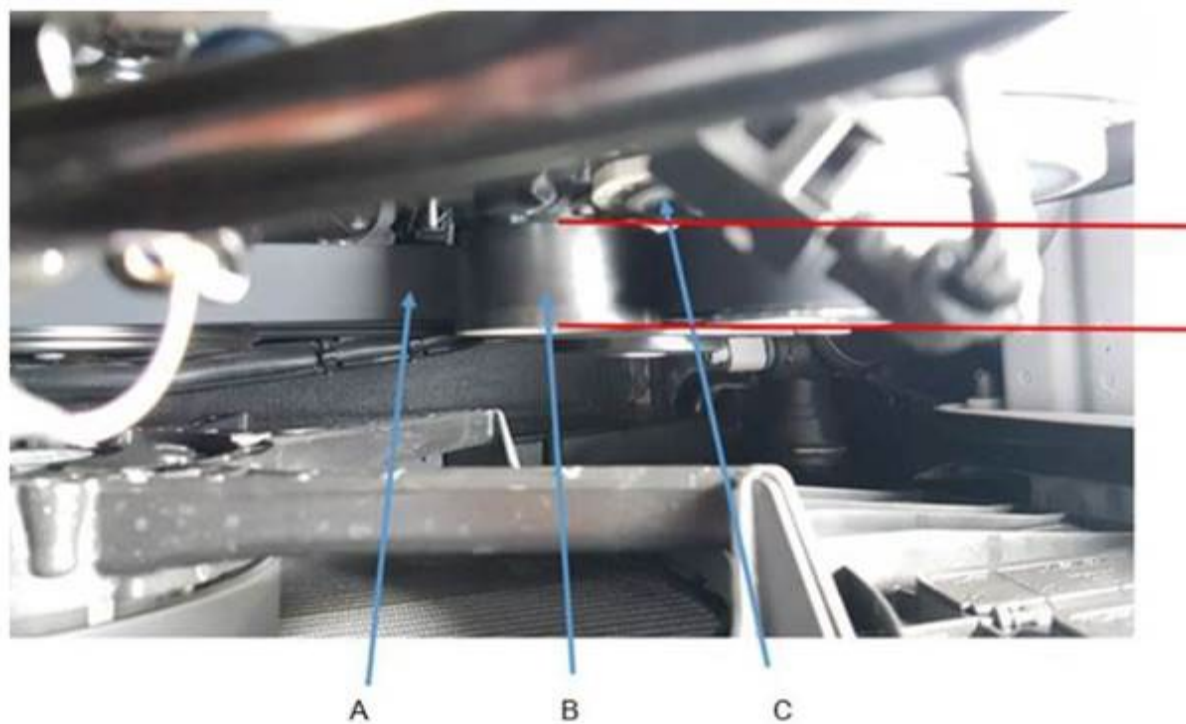
1. Run the engine at idle speed.
2. The belt must not protrude forward or backward over the roller edge of the tensioner (Figure 2, red marks).

Figure 2. Check to ensure that the poly V-belt is not protruding in either direction.

1. Replace the belt tensioner and poly V-belt. **If a new belt tensioner has already been installed, do not replace it again.**

Check for correct belt running alignment after poly V-belt and tensioner replacement as follows:

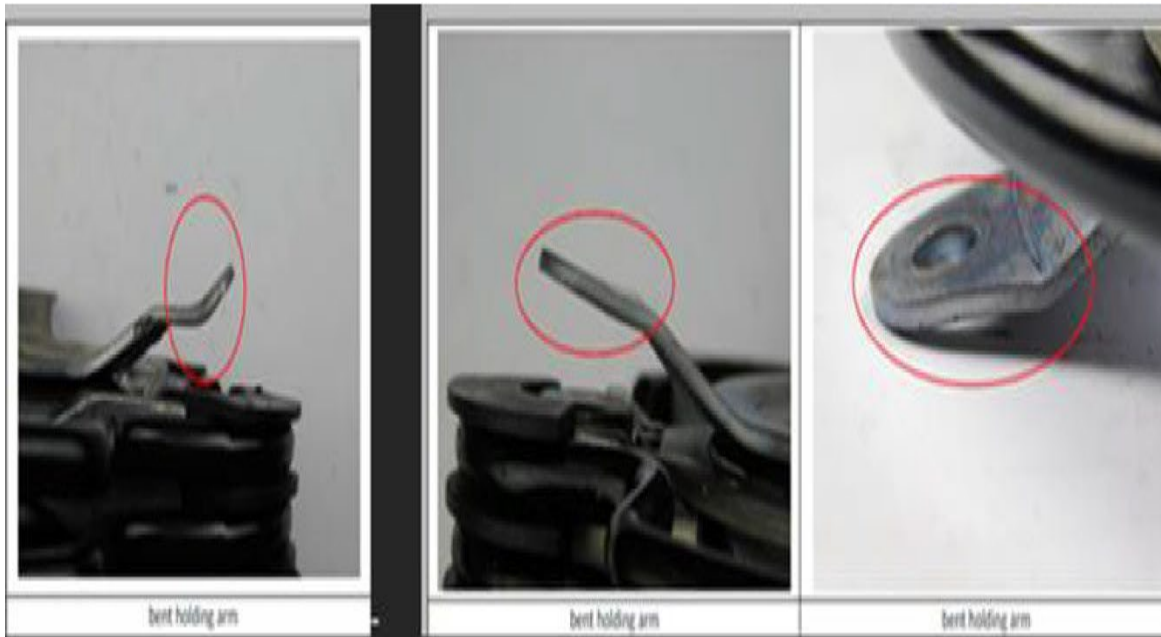
Example of damaged parts:

Please ensure that the belt tensioner (including the retaining tab) is not damaged during removal. Damage to the component would make analyzing the parts impossible. In such cases, we may charge back the damaged parts.
