Service Bulletin

Bulletin No.: 23-NA-115

Subject: Ticking, Tapping or Snapping Noise from Engine - 5.5L RPO LT6 Realign Camshaft Caps as Required

Brand:	Model:	Model Year:		VIN:		Engine:	Transmission:
		from	to	from	to		
Chevrolet	Corvette	2023	2024	—	—	5.5L (RPO LT6)	—

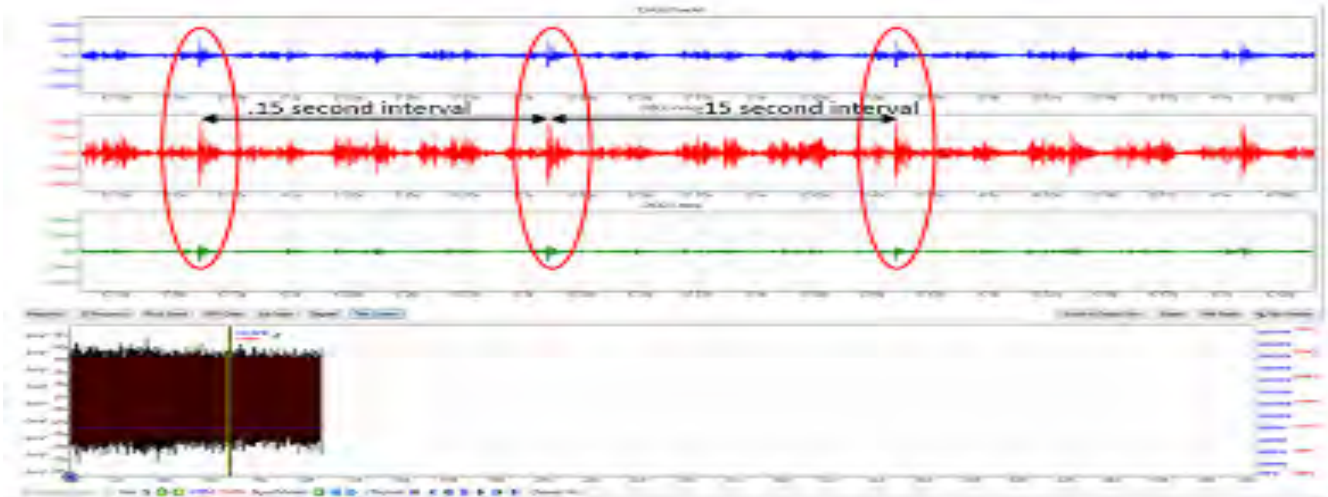
Examples of Tick:

1. Right click in the time domain display and change the display mode to single.
2. If scales on the left end for each channel are not ranging from -4 m/s^2 to 4 m/s^2 , right click in the time domain display and select "reset scale."
3. Pull the yellow window cursors on the bottom in as close together as they will go.
4. Look at the channel lines in the time domain window for ticks with a .15s gap between them.
⇒ Compare to the examples below for an engine with a tick and an engine without a tick:

Once it is determined which bank the noise is coming from, it will be necessary to follow the service procedure below to adjust the camshaft cap torque.
