Service Bulletin

Bulletin No.: 24-NA-046

Subject: Suction Cup Marks on Window Glass

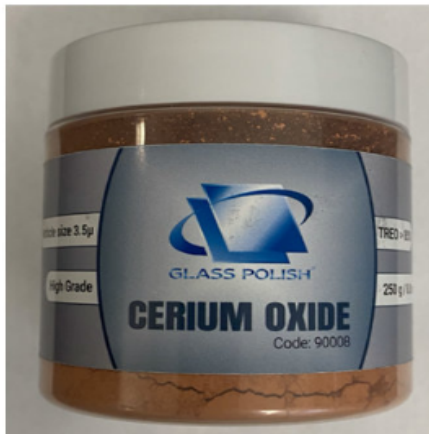
6568173

Cause	The cause of the condition may be the supplier had glass-handling suction cups that were not properly maintained. The suction cups picked up abrasive dust from the environment and when the tools were used, they caused a "scuff" on the glass that holds moisture in a geometric pattern matching the suction cup.
Correction	Using the products listed below polish the location.

Obtain commercially available Cerium Oxide glass polish and follow the instructions for light hand polishing.
