Technical Service Bulletin

80 Poor, uneven or no cabin heating output

80 24 14 2073370/1 March 12, 2024.

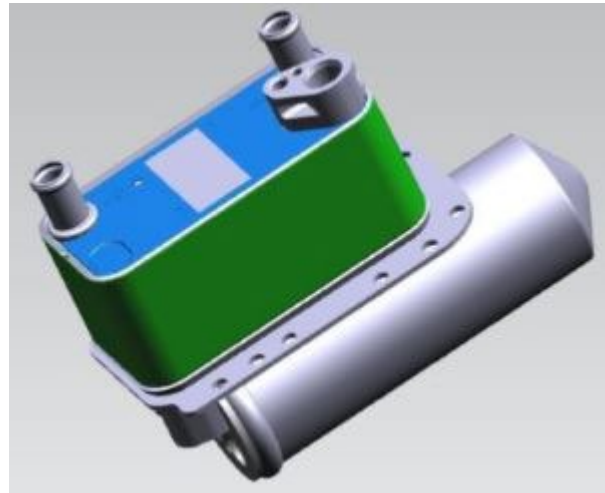
The complaint can be reproduced. Diagnosis finds obstructed or blocked coolant flow through the heat exchanger (4M0816413A).

Deposits in the cooling system can accumulate in the heat exchanger and obstruct coolant flow. The quality of the cabin heating is then compromised.

Figure 1. Heat exchanger 4M0816413A.

Before replacing the heat exchanger flush the component with water in the opposite flow direction in attempt to clear the deposits. If the flushing process is not successful and deposits remain in the component replace the heat exchanger. Refer to the cooling system flushing procedures in ElsaPro or TSB 2062583 “80 The interior vehicle heating is insufficient, and the engine coolant is discolored” if additional guidance is required.

Please exercise care not to contaminate the refrigerant side of the heat exchanger with water, coolant, moisture, etc. Thoroughly seal off the refrigerant side of the heat exchanger to avoid any intrusion of moisture or contaminants during the cleaning procedure.
