# Technical Service Bulletin

## 91 ConBox: Wireless Audi Smartphone Interface (CarPlay / AndroidAuto) inop

91 24 85 2073333/1 March 12, 2024.

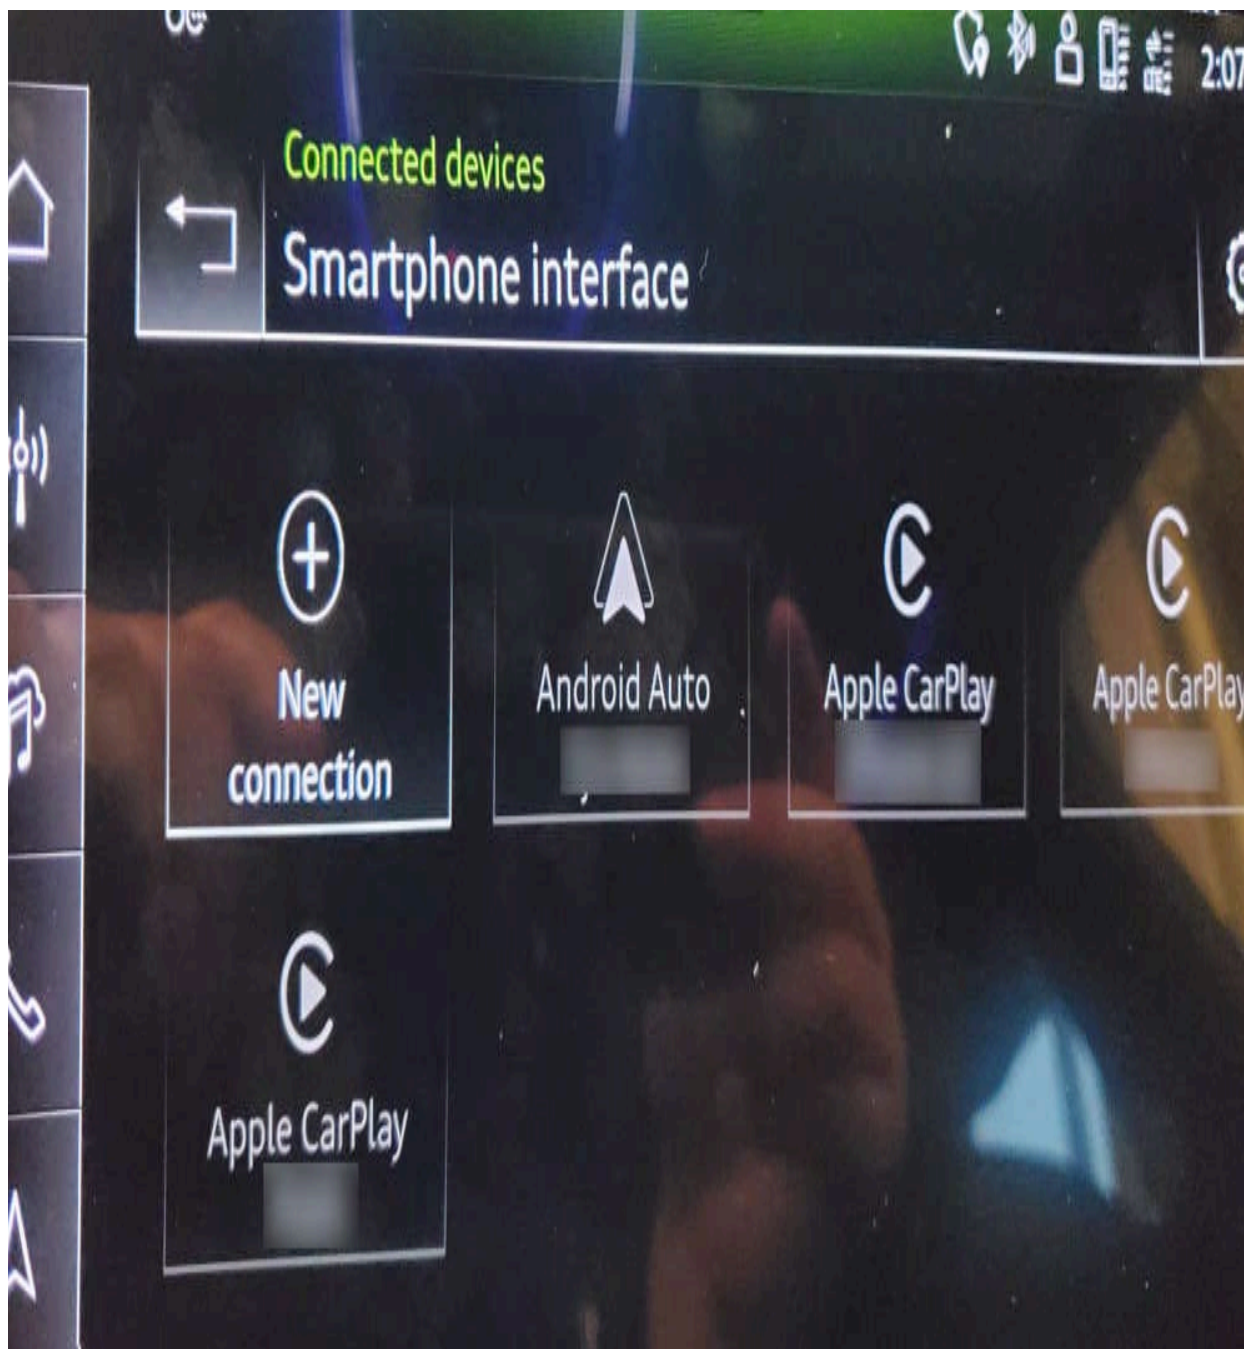
- The Audi Smartphone Interface [ASI] (Apple CarPlay [ACP] / AndroidAuto [AA]) cannot be paired to the phone wirelessly.
- The phone tiles under the ASI menu are grayed out (see Figure 1).

**Figure 1:** wASI connections grayed out.

Due to a configuration issue, the 5GHz WiFi may not be available in some vehicles, preventing wASI from functioning.

Please execute the “*Check control module configuration*” test plan under Guided Functions for the Emergency Call Module and Communication Unit (ConBox) -J949- (address word 0075).
