Technical Service Bulletin

94 Warning for 3rd brake light: DTC B12C615

94 24 75 2073316/1 March 12, 2024.

Model(s)	Year	VIN Range	Vehicle-Specific Equipment
A3, S3, and RS 3	2020 - 2024	All	Not Applicable

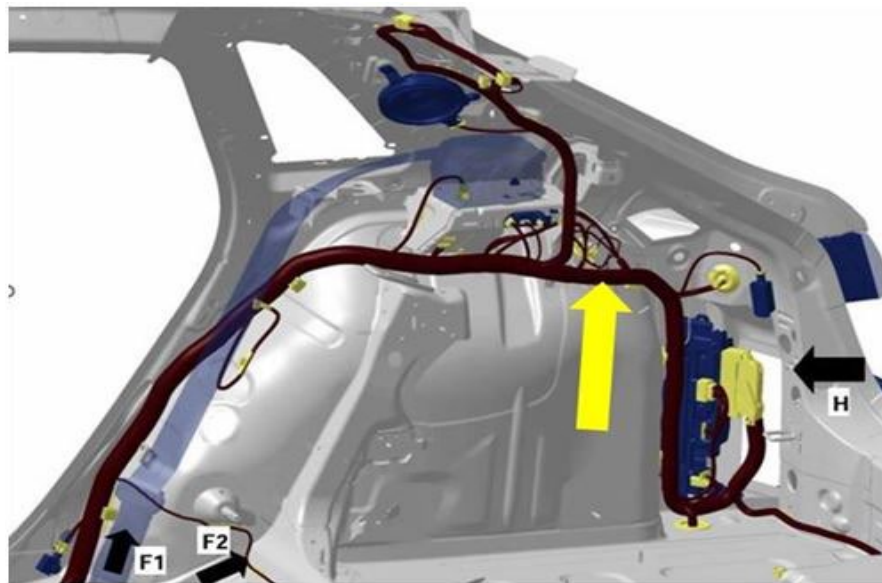
The suppression capacitor C24 is located near the yellow arrow on the right side of the luggage compartment. (Figure 1).

Figure 1: C24 location near the ground stud 22.

5. Remove the suppression capacitor C24 using the steps below:

- Gain access to the C24 suppression filter.

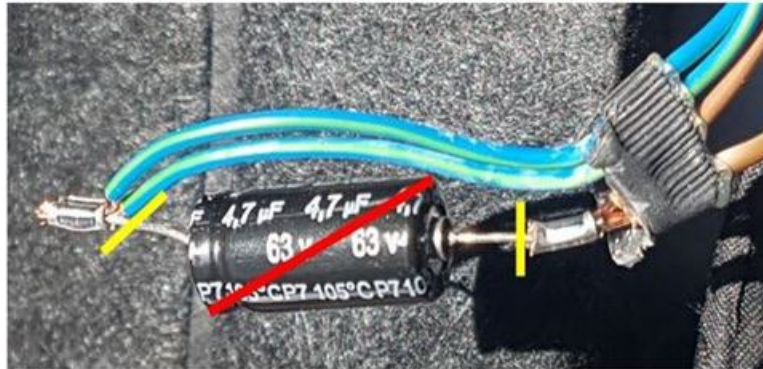
Figure 2: Suppression capacitor C24.

- Remove the heat-shrink from around the capacitor.
- At the yellow highlighted area, cut and remove the capacitor from the wiring harness (Figure 2).

- Insulate the exposed crimps using heat-shrink hose from **VAS 1978B** wire harness repair set and then wrap the wiring harness in fabric adhesive tape **N 10592002**
