Technical Service Bulletin

87 Faint noise heard in cabin from air conditioning circuit

87 24 68 2044717/10 March 8, 2024. Supersedes Technical Service Bulletin Group 87 number 19-93 dated July 12, 2019 for reasons listed below.

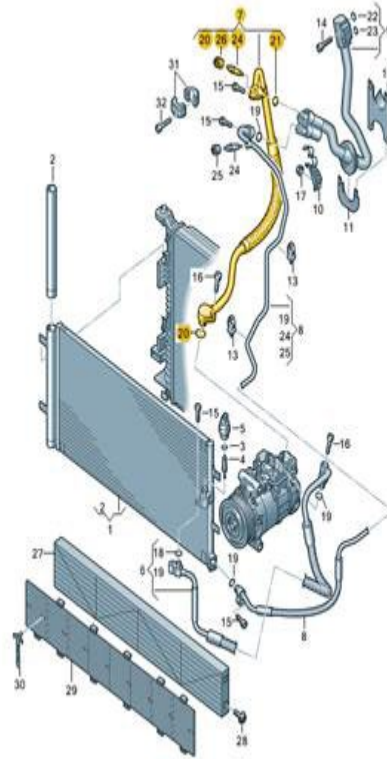
Figure 1. The low side line that needs to be replaced.

1. Replace the low side refrigerant line that connects the air conditioning compressor suction port to the hybrid refrigerant line to the expansion valve (Figure 1). Be certain to use new O-rings at these and all refrigerant circuit joints that are disconnected.

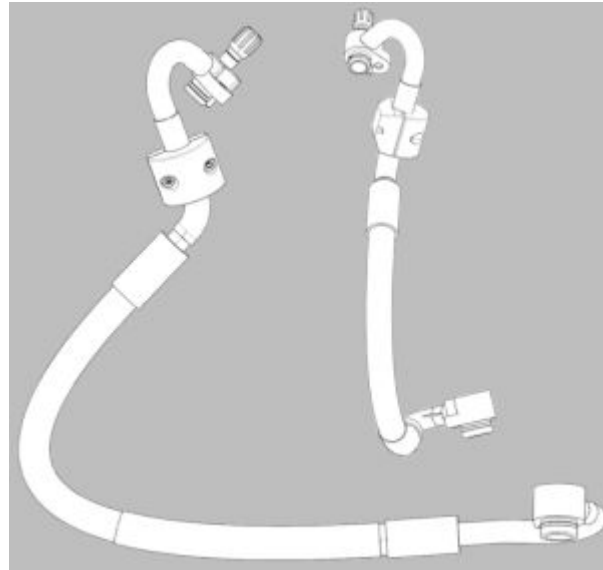
Figure 2. Balance weight position on the low side line.

2. Install the balance weight (part number 4G0513621A) with 2 bolts (part number N 10653601) to the line in the position shown in the illustration (Figure 2).
