<b>REFERENCE:</b>	<b>TSB:</b> 08-020-24 <b>GROUP:</b> 08 - Electrical	<b>Date:</b>	January 13, 2024	<b>REVISION:</b>	-
<b>VEHICLES AFFECTED:</b>	<b>2018 - 2023 (JL) Jeep Wrangler</b> <b>2020 - 2023 (JT) Jeep Gladiator</b> This bulletin applies to vehicles equipped with a Remote USB Port (Sales Code RSX).	<b>MARKET APPLICABILITY:</b>			
		<input checked="" type="checkbox"/> NA <input type="checkbox"/> MEA <input type="checkbox"/> SA <input type="checkbox"/> IAP <input type="checkbox"/> EE <input type="checkbox"/> CH			
<b>CUSTOMER SYMPTOM:</b>	<b>Customers may comment on the following:</b> <ul style="list-style-type: none"> <li>Customer states the Apple Carplay/Android Auto™ does not work or is intermittently working when their device is plugged into the center console bin USB port.</li> </ul>				
<b>CAUSE:</b>	<b>Misfit USB cable Fig.1.</b>

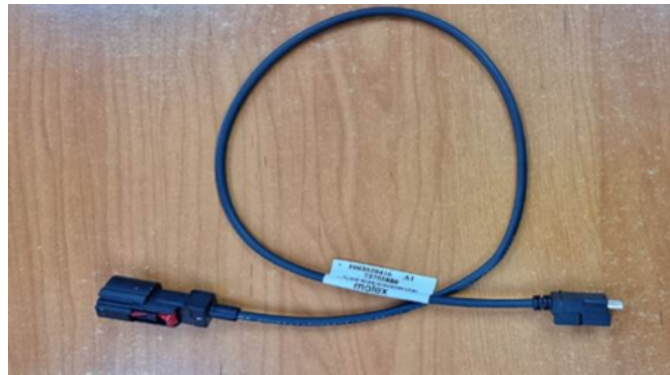
**Fig. 1**  
USB Cable For Center Console Harness

This replacing the center console USB cable.

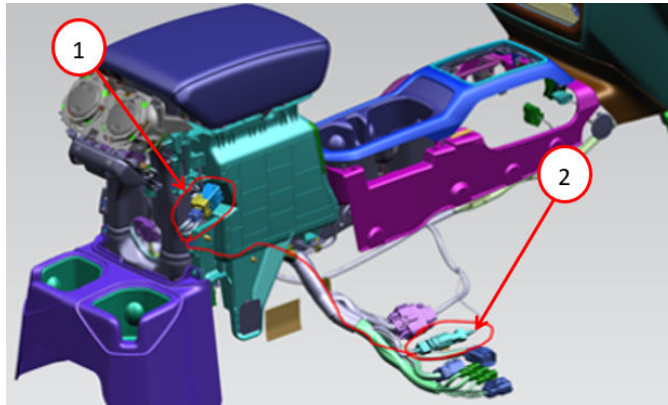
**Fig. 2**  
USB Connection End to End

1 - USB Port to Floor Console End Cap  
2 - USB Cable to Wire Harness Connector

1. Remove the floor console. Refer to the detailed service procedures listed in DealerCONNECT> Service Library under: 23 - Body / Interior / Console, Floor / Removal.
2. Remove the end cap from the floor console. Refer to the detailed service procedures listed in DealerCONNECT> Service Library under: 23 - Body / Interior / Console, Floor, End Cap / Removal.
3. Disconnect off the existing USB connector and connect the **NEW** USB cable to the media port.
4. Using zip ties, secure cable to existing console harness every 150mm (6 inches) to avoid a Buzz, Squeak or Rattle (BSR) condition when routing to the bracket under the passenger seat [Fig. 2](#).

**NOTE: Perform push-pull-push on each connection to ensure the connector is fully seated.**
