Service Bulletin

Bulletin No.: 06-06-01-019C

Date: March, 2024

Subject: Information on Gradual Coolant Loss Over Time with No Evidence of Leak Found

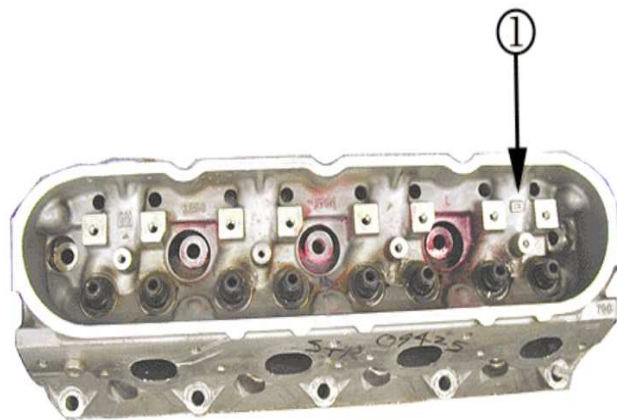
1860180

Cylinder head(s) location of the **Castech** manufacturing casting logo (1).

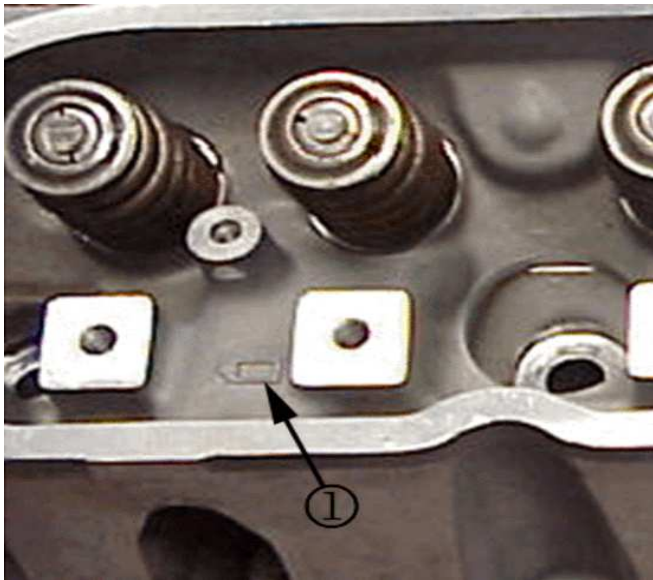
1860178

Close up view of the cylinder head(s) showing the **Castech** manufacturing casting logo (1).

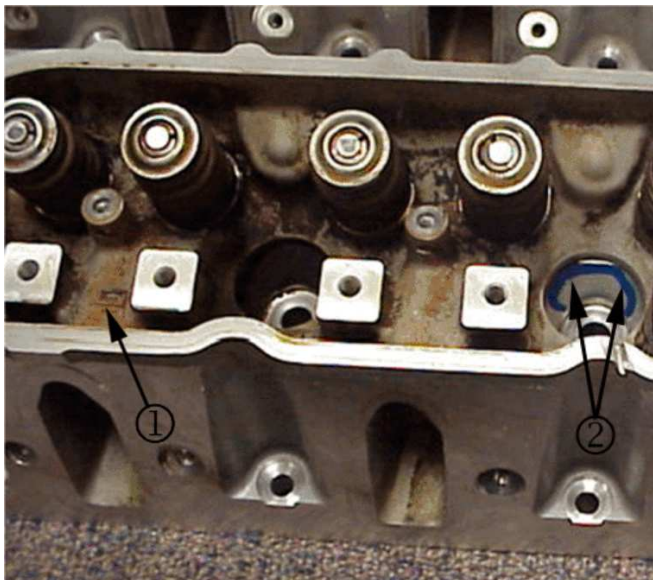
1860179

If the cylinder head(s) is a **Castech** casting (1), inspect the area around the five oil drain holes for witness marks indicating coolant seepage over time (2).

Important: If **No** evidence of coolant loss is found on inspection of **Castech** casting cylinder head(s), follow normal diagnostic procedures in SI to determine the cause of the coolant loss.

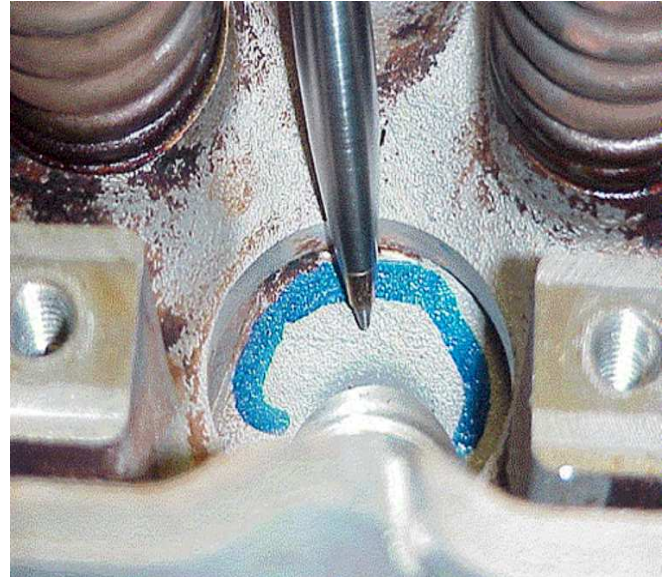
1860181

The crack location can be found in any of the five-cylinder head(s) oil drains. This can be seen as a clean or shiny area, on an otherwise stained surface (1). Pressurizing the cooling system at this time may reveal coolant, air, or a combination, weeping in the described area. If inspection reveals evidence of coolant witness marks (1), replace the entire cylinder head(s) assembly.
