# Service Bulletin

Bulletin No.: 22-NA-028

**Subject:** Whining/Whirring, Whistle, Squeaking, Groaning/Growling Noise Coming from Front Wheel/Engine Area

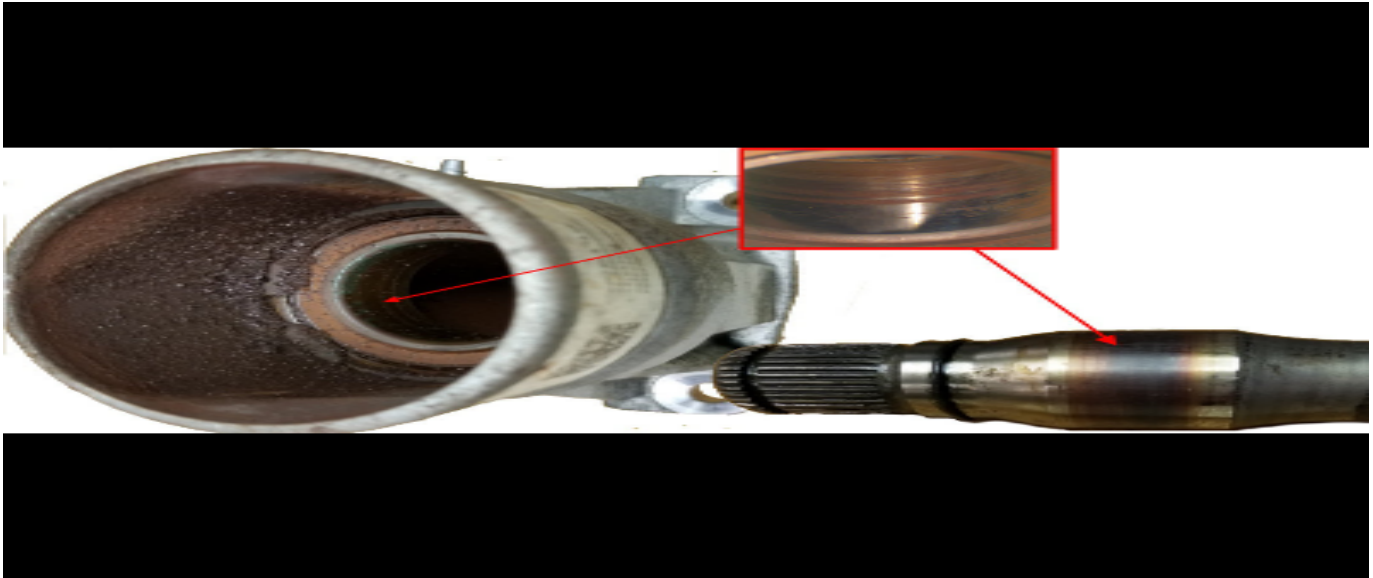
5875997

**Note:** Fretting worn IDS shaft and bracket must be discarded and replaced with new parts.
