# Service Bulletin

Bulletin No.: 22-NA-223

**Subject:** Information on Binding, Clicking and/or Chattering Noise Coming From the Rear of the Vehicle While Making Tight Turns

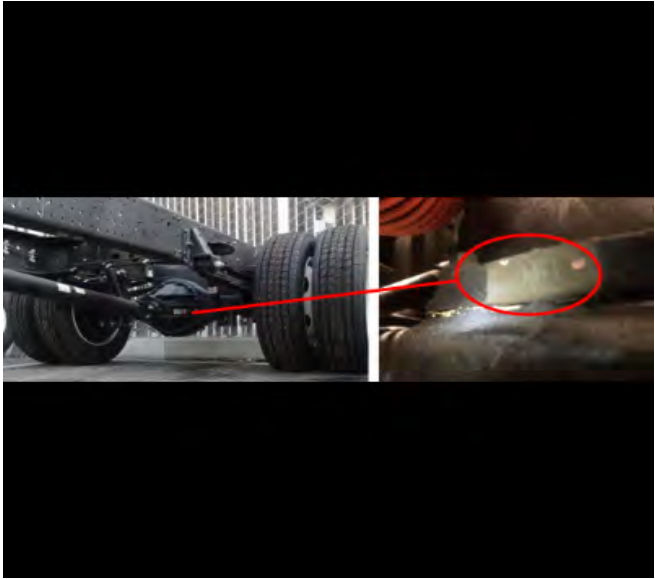
<p style="text-align: right;">6182582</p> <p>Refer to the graphic above to identify a limited slip differential or check the vehicle build in IVH (Investigate vehicle History) for Option Code G86.</p> <p>– LSD Stamp Codes</p> <ul style="list-style-type: none"> <li>• B7</li> <li>• D0</li> <li>• D8</li> <li>• D9</li> <li>• H0</li> <li>• H9</li> </ul> <p>To resolve this problem, take the following steps/actions.</p> <ol style="list-style-type: none"> <li>1. Replace the differential gear oil with a commercially-available gear oil (SAE80W-90 GL-5, SAE90 GL-5) and add 20oz of limited slip differential lubricant additive (P/N 88900330 (quantity of five (5), 4oz bottles). Refer to Fluid and Lubricant Recommendations in SI.</li> <li>2. Road test the vehicle for at least 10 miles by making eight to ten tight left and right turns, such as going around a corner, to ensure the limited slip is activated and to determine if there is no longer any audible clicking or chattering noise coming from the rear of the vehicle during tight turns.</li> <li>3. If the condition persists, technicians are to call the Technical Assistance Center (TAC)</li> </ol>
