Service Bulletin

Bulletin No.: 24-NA-047

Subject: Interior Indented Door Panel

Brand:	Model:	Model Year:		VIN:		Engine:	Transmission:
		from	to	from	to		
Cadillac	Escalade	2022	2024				
	Escalade ESV

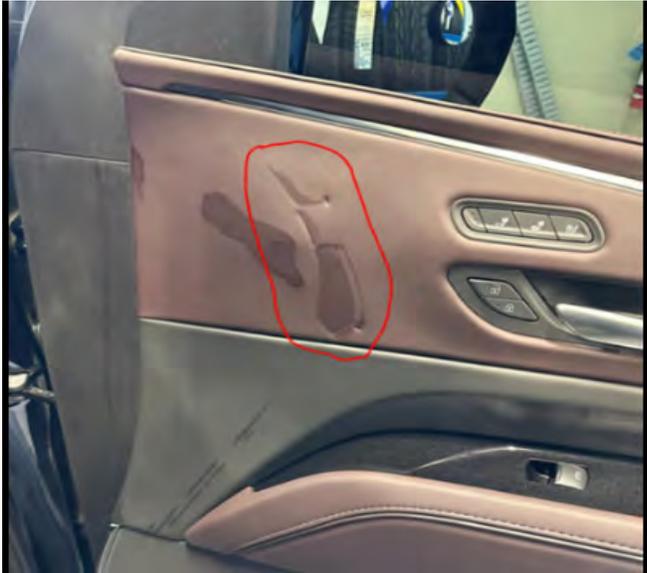
<p style="text-align: right;">6570306</p>
Note:	Example of door panel indentation. Damage can vary or be only slightly visible.
Cause	The cause of the condition may be the edge material from the bezel/bolster has excessive contact pressure against the door panel retention clip when doors are closed.

Correction	Replace the door panel and grind down the door panel retention clip. Important: Refer to the Electronic Parts Catalog (EPC) for the proper color door panel.
