# Service Bulletin

Bulletin No.: 23-NA-115

**Subject:** Ticking, Tapping or Snapping Noise from Engine - 5.5L RPO LT6 Realign Camshaft Caps as Required

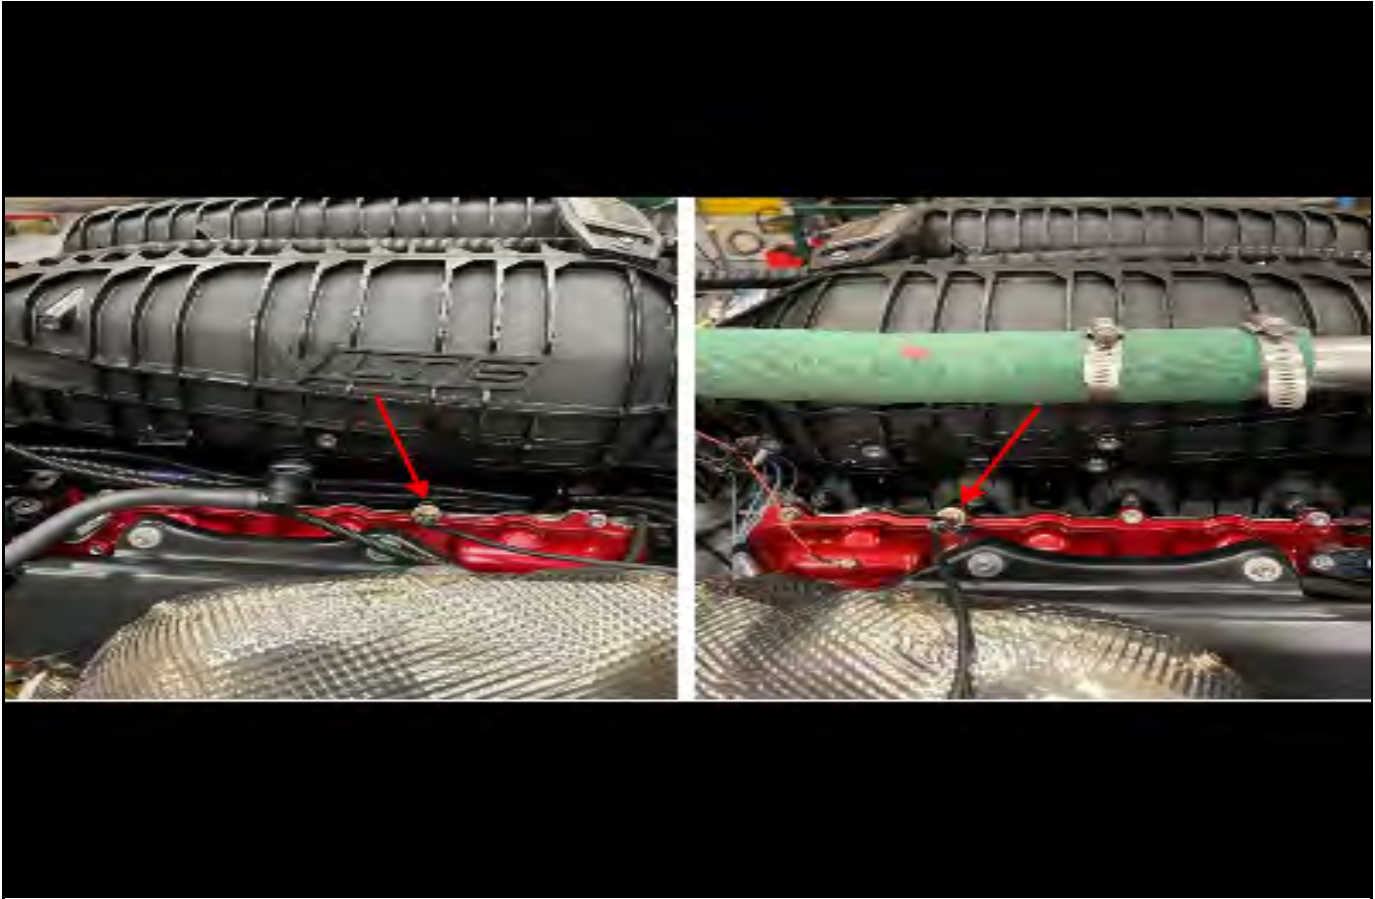
Place the accelerometer on the suspect bank.

⇒ With the suspect bank determined, prep/position the accelerometer so the X, Y, Z coordinate system (that's laser etched) is facing upwards before securing to the bolt head. After accelerometer is placed on bolt head, double check to ensure its centered and did not rotate on the bolt head. Doing so will ensure the best results.

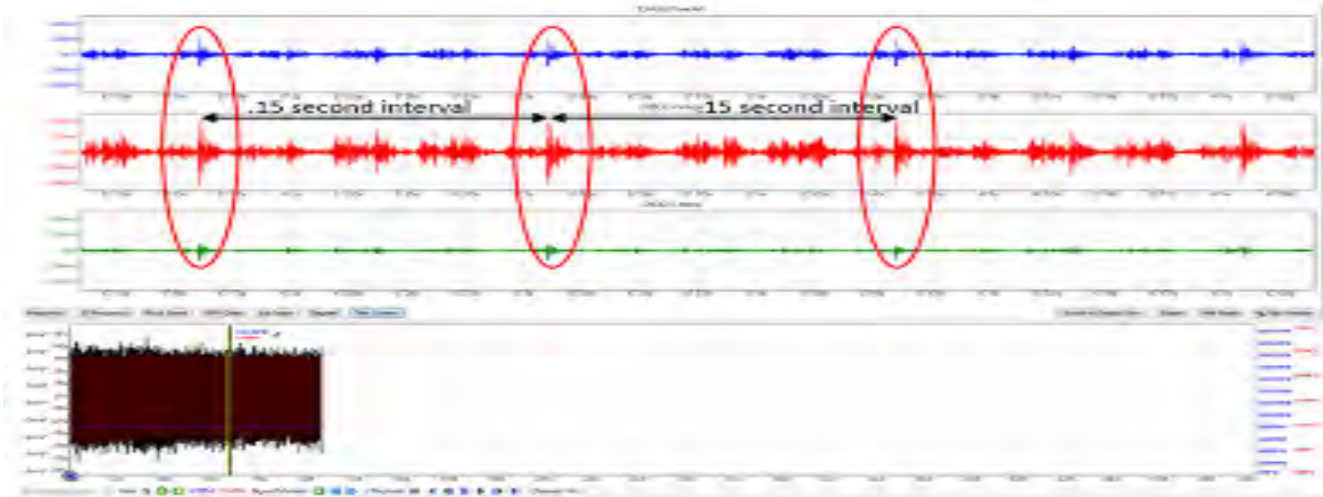
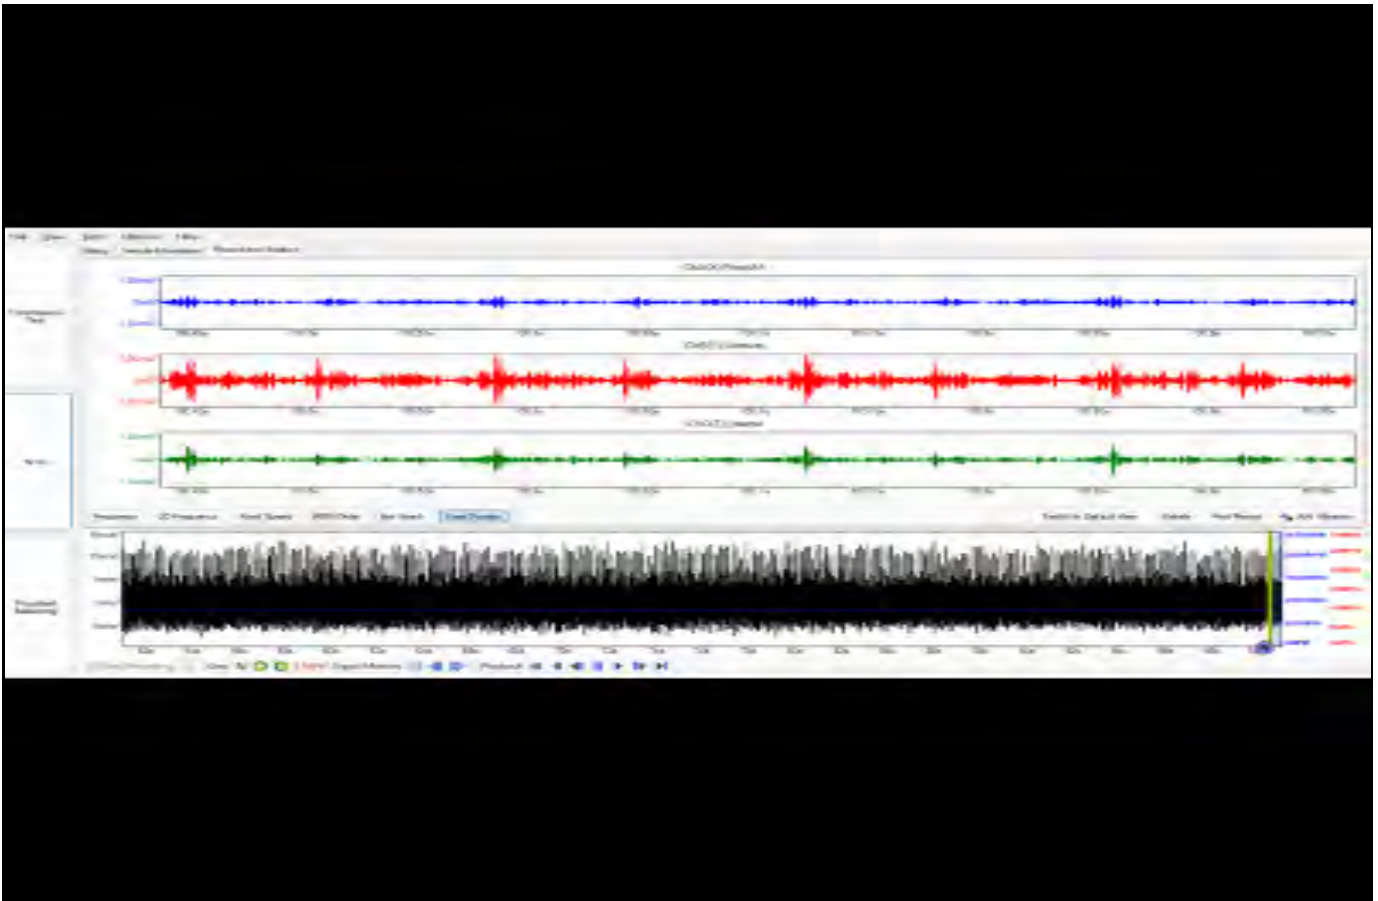
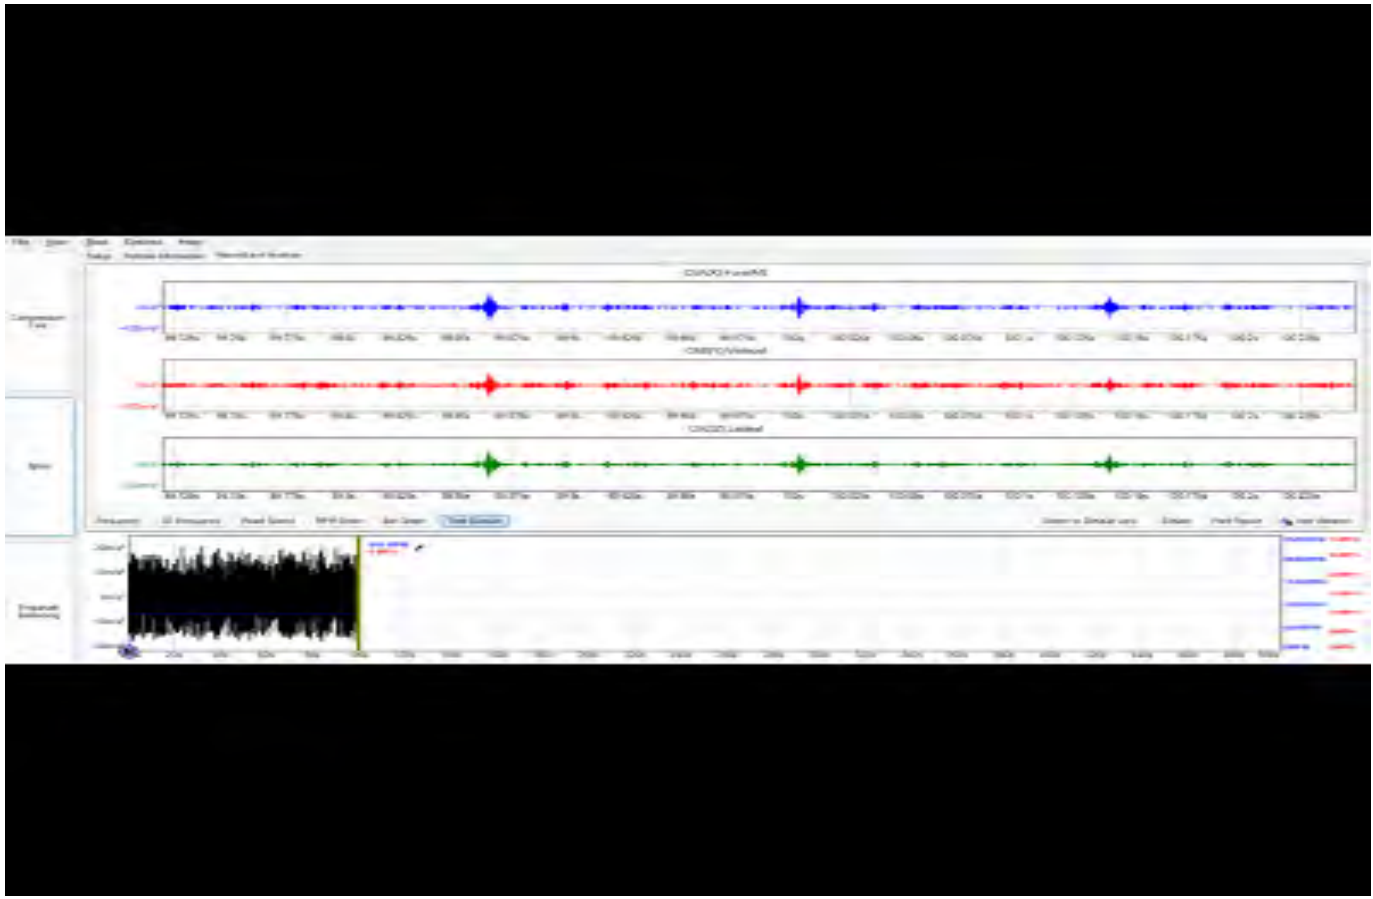
Examples of Tick:

- Right click in the time domain display and change the display mode to single.
- If scales on the left end for each channel are not ranging from -4 m/s<sup>2</sup> to 4 m/s<sup>2</sup>, right click in the time domain display and select “reset scale.”
- Pull the yellow window cursors on the bottom in as close together as they will go.
- Look at the channel lines in the time domain window for ticks with a .15s gap between them.
  - ⇒ Compare to the examples below for an engine with a tick and an engine without a tick:

Once it is determined which bank the noise is coming from, it will be necessary to follow the service procedure below to adjust the camshaft cap torque.
