91-23-03 - MIB3 Various Infotainment Concerns

Release date: 3/19/2024

Model(s)	Year	Eng. Code	Trans. Code	VIN Range From	VIN Range To	PR Code(s)
Arteon, Atlas, Atlas Cross Sport, Golf/GTI, Jetta, Tiguan	2021	All	All	All	All	8AR
Arteon, Atlas, Atlas Cross Sport, Jetta, Taos, Tiguan	2022 - 2023	All	All	All	All	8AR

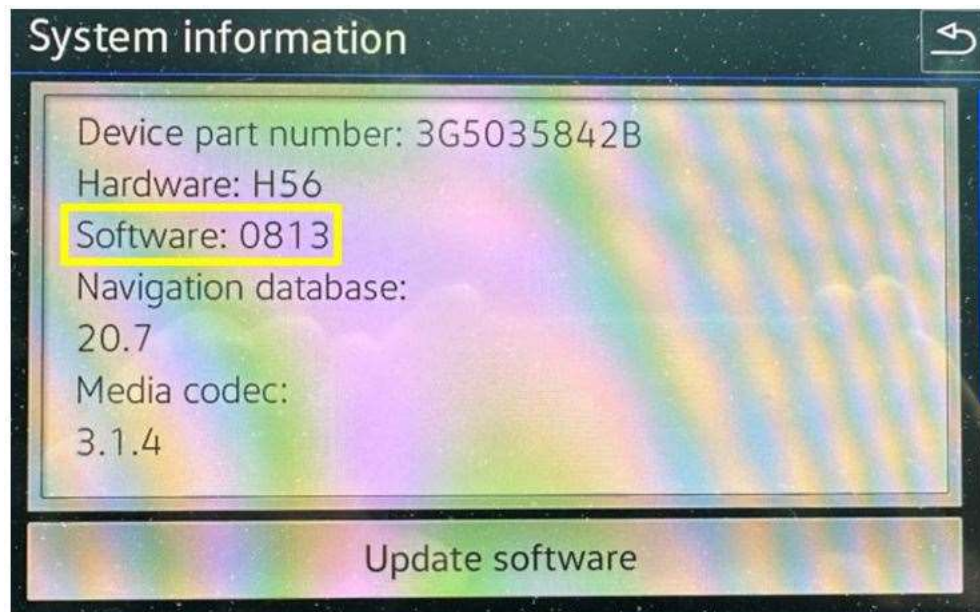
In "System Settings", scroll down to select "System Information" from the touchscreen menu.

If the "Software" level is lower than **0841**, proceed with this Technical Bulletin.

If the "Software" level is equal to or greater than **0841**, this work procedure does not apply.
