GENERAL MOTORS
DCS6836
URGENT - DISTRIBUTE IMMEDIATELY

Subject: N232429880 - Service Update
Battery Energy Control Module

Models: 2023 BrightDrop Zevo 600
2023 – 2024 Cadillac LYRIQ
2022 – 2023 GMC HUMMER EV
2024 GMC HUMMER EV Pickup
2024 GMC HUMMER EV SUV

N232429880 Battery Energy Control Module

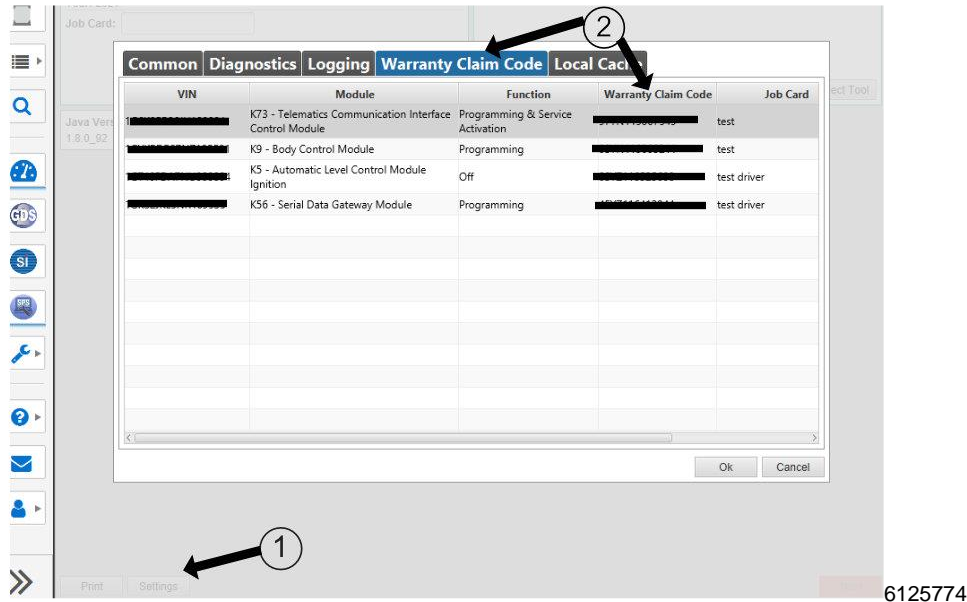
If the Warranty Claim Code was not recorded on the Job Card, the code can be retrieved in the SPS2 system as follows:

- Open TLC on the computer used to program the vehicle.
- Select and start SPS2.
- Select Settings (1).
- Select the Warranty Claim Code tab (2).

The VIN, Warranty Claim Code and Date/Time will be listed on a roster of recent programming events. If the code is retrievable, dealers should resubmit the transaction making sure to include the code in the SPS Warranty Claim Code field.

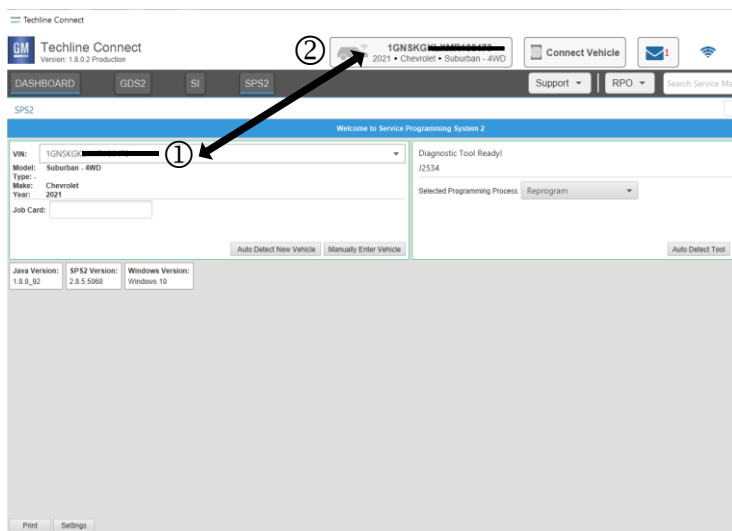
5743643

Caution: Be sure the VIN selected in the drop down menu (1) is the same as the vehicle connected (2) before beginning programming.

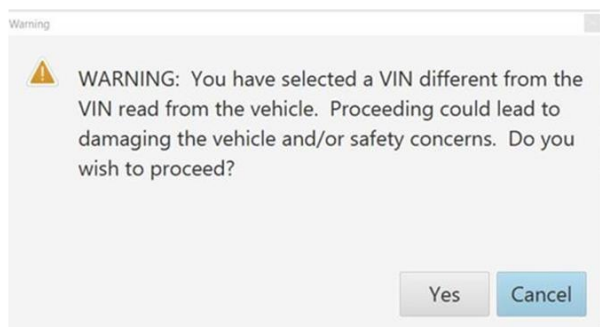
5877000

Important: If the vehicle VIN DOES NOT match, the message below will be shown.

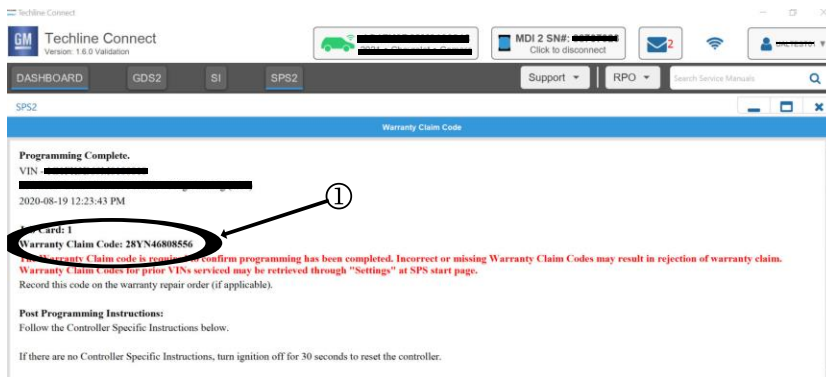
5644478

Important: To avoid warranty transaction rejections, you **MUST** record the warranty claim code provided on the Warranty Claim Code (WCC) screen shown above on the job card. Refer to callout 1 above for the location of the WCC on the screen.

1. Reprogram the Battery Energy Control Module. Refer to *K16 Battery Energy Control Module: Programming and Setup* in SI.

2. Record SPS Warranty Claim Code on job card for warranty transaction submission.

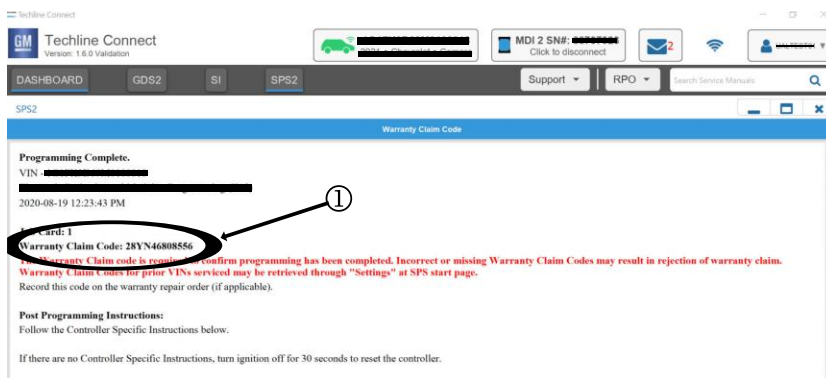
5644478

Important: To avoid warranty transaction rejections, you **MUST** record the warranty claim code provided on the Warranty Claim Code (WCC) screen shown above on the job card. Refer to callout 1 above for the location of the WCC on the screen.

2. Record SPS Warranty Claim Code on job card for warranty transaction submission.
