# Technical Service Bulletin

## 91 ConBox: Wireless Audi Smartphone Interface (CarPlay / AndroidAuto) inop

91 24 88 2073333/2 March 22, 2024. Supersedes Technical Service Bulletin Group 91 number 24-85 dated March 12, 2024 for reasons listed below.

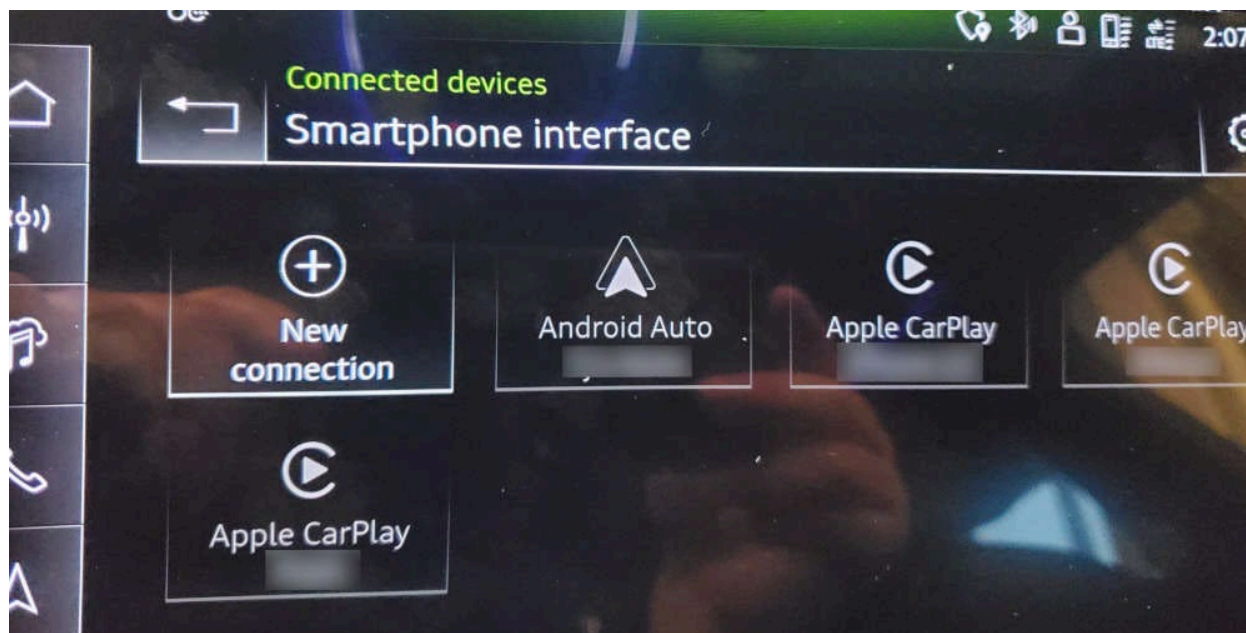
- The Audi Smartphone Interface [ASI] (Apple CarPlay [ACP] / AndroidAuto [AA]) cannot be paired to the phone wirelessly.
- The phone tiles under the ASI menu are grayed out (see Figure 1).

**Figure 1:** wASI connections grayed out.

Due to a configuration issue, the 5GHz WiFi may not be available in some vehicles, preventing wASI from functioning.

1. Please execute the “*Check control module configuration*” test plan under Guided Functions for the Emergency Call Module and Communication Unit (ConBox) -J949- (address word 0075).

2. After a bus sleep cycle, the correct functionality should be reestablished.
