Service Bulletin

Bulletin No.: 20-NA-166

Subject: Information on Malfunction Indicator Lamp (MIL) Illuminated – DTCs P050D and/or P0300 Setting on a Cold Start and/or Engine Runs Rough when Warm with No Codes

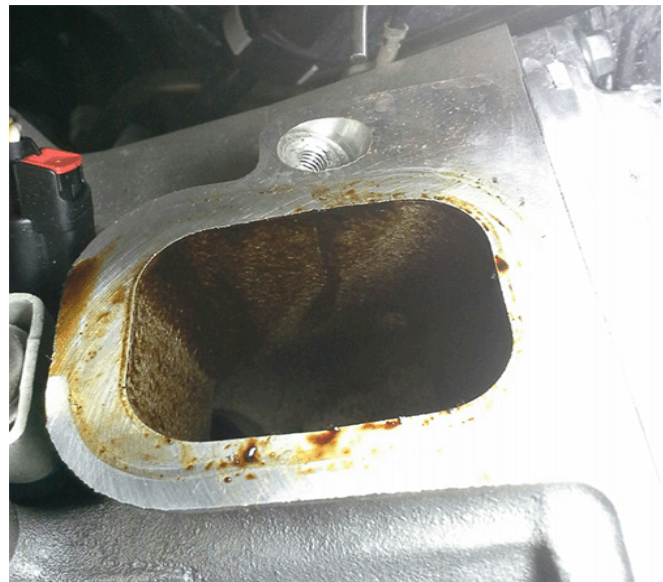
4806659

If the head casting line is the concern, the intake port will be wet with a coolant oil mix.

This could be the cause of a running rough warm concern with or without codes.

The location of where the coolant is running down in the port will also look washed down.

If this is found, the cylinder head will need to be replaced.

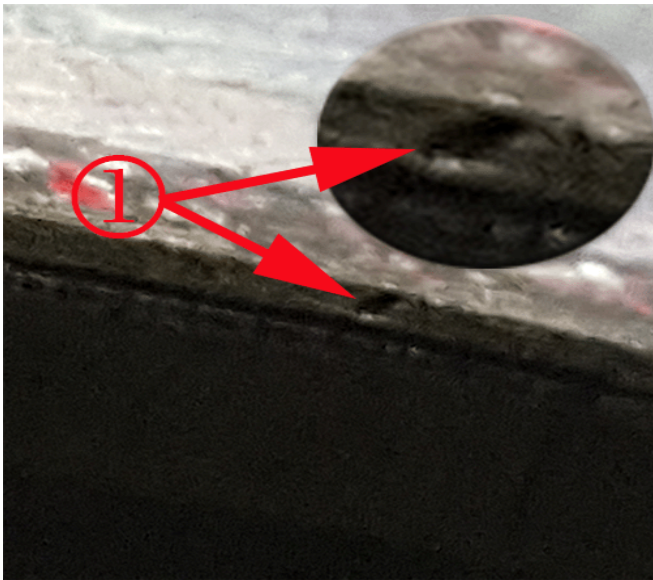
4806657

It is also possible to have coolant entry at the liner to deck face casting of the cylinder bore (1). It is hard to see the actual source (pin hole), but it usually streams down the liner so that you can see it with a borescope. (Sometimes) The top of the piston will be steam cleaned.

Do not confuse residual fuel on the piston crown / surface as coolant. Some fuel residue may be present and can be mistaken as coolant (reason for the cooling system Dye to be added). Use a black light to confirm the liquid is coolant. If this concern is present, do not replace the cylinder head because that will not repair this concern. Call the Product Quality Center (PQC) per Service Bulletins 20-NA-138 (U.S.) or 16-NA-338 (Canada), if required, reference this bulletin and replace the engine.
