# Tech Tips

TT 72-12-02

## 2011-2013 Touareg – Front Seat Backrest is in a Different Position When Re-entering the Vehicle

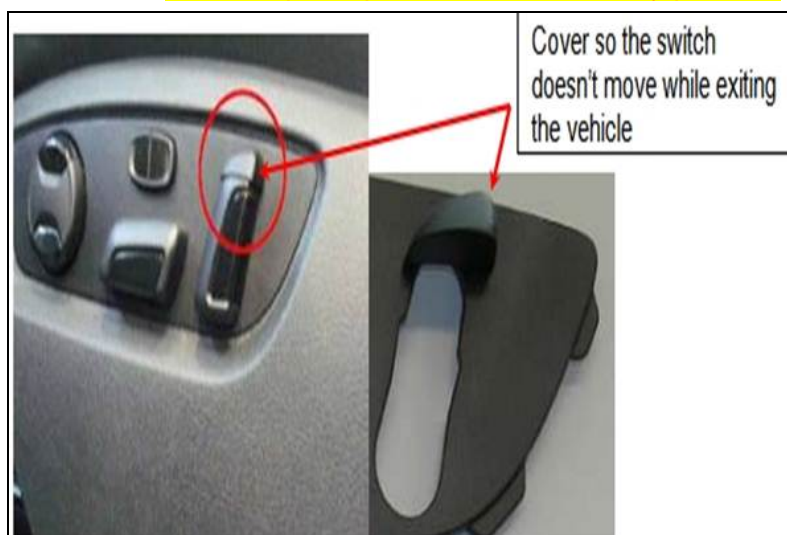
Customer concern of seat backrest in a different position when re-entering the vehicle may be caused by customer contacting backrest adjustment switch while exiting the vehicle. To prevent contact with switch, install updated switch trim panel with added cover over backrest adjustment switch as shown below. Backrest adjustment knob must also be replaced with part number 7P6959817B QWA (left) and 7P6959818B QWA (right). Be aware that the trim panel part number is based on vehicle trim level. Part numbers are as follows:

7P6 882 515E 9B9 (driver side) / 7P6 882 516E 9B9 (passenger side) Sport trim level (8-way seat)

7P6 882 515D 9B9 (driver side)/ 7P6 882 516D 9B9 (passenger side) Lux, Executive and Hybrid trim levels (12-way seat)

**Note:** Do not replace parts if cover is already present.
