22-24MY Tundra and Tundra HV, V35A Engine, Oil Leak from Oil Filter Sealing Surface

2022-2024 MY Tundra and Tundra HV

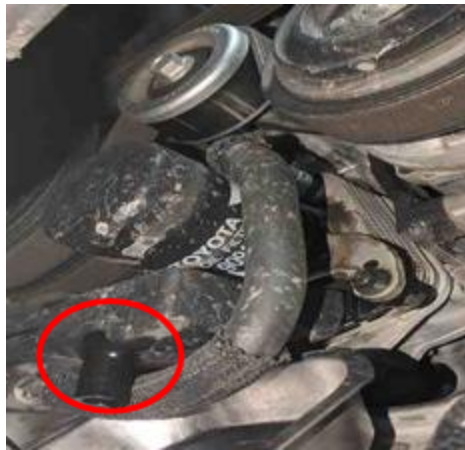
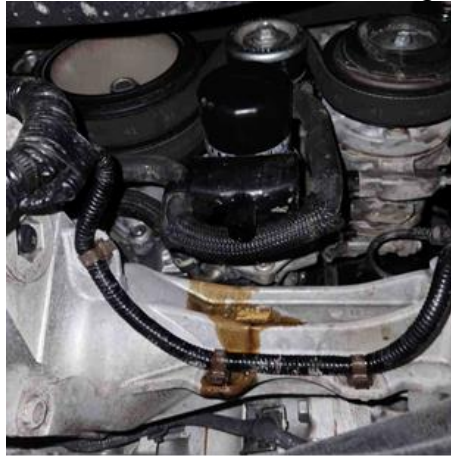
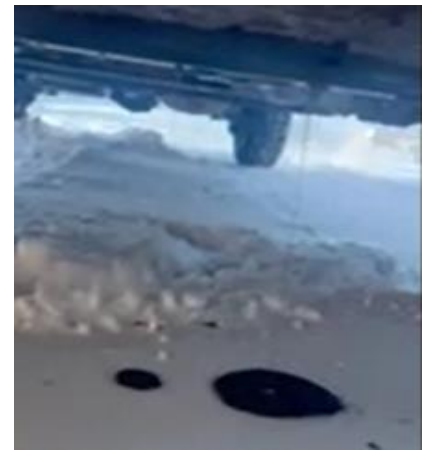
Vehicle may exhibit an oil leak from the sealing surface between the Oil Filter (PN: 9091510010) and the Oil Cooler (PN: 15710-F4010) in cold weather with sub-freezing temperatures.

If a vehicle is experiencing an oil leak anywhere around the Oil Filter gasket, please do the following:

1. Take clear pictures of the origin of the leak.
2. Please create a TAS case and contact TAS for instruction prior to diagnosing or repairing of the vehicle. If it is a weekend or holiday, continue with diagnosis and repair. Please save all parts and/or details and contact TAS on the next available workday.
