# MIL ON With DTC P060694

YEAR(S)	MODEL(S)	ADDITIONAL INFORMATION
2021 - 2023	Sienna HV	WMI(s): 5TD Transmission(s): eCVT Plant Code(s): S

Some 2021 – 2023 model year Sienna Hybrid vehicles may exhibit a MIL ON condition with Diagnostic Trouble Code (DTC) P060694 (Hybrid/EV Powertrain Control Module Processor Unexpected Operation) present. The Hybrid Vehicle Control Computer logic has been modified to reduce the possibility of this DTC setting incorrectly. Follow the Repair Procedure in this bulletin to address this condition.

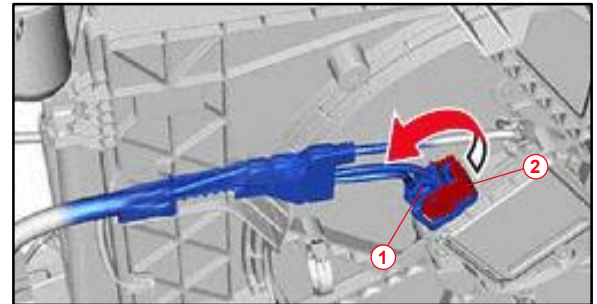
**Figure 1.**

<b>1</b>	Cooling Fan Motor Connector
<b>2</b>	Lock

2. Disconnect the cooling fans.

- A. Disconnect the cooling fan motor connector.
- B. Rotate the lever while pushing the lock and disconnect the cooling fan motor connector.

After disconnecting the cooling fan motor connector, make sure that dirt, water, or other foreign matter does NOT contact the connecting parts of the cooling fan motor connector.

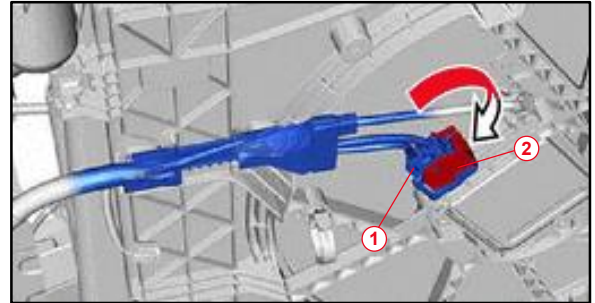
**Figure 2.**

1	Cooling Fan Motor Connector
2	Lock

4. Connect the cooling fans.
  - A. Connect the cooling fan motor connector.
  - B. Rotate the lever to lock it.

- When connecting the cooling fan motor connector, make sure that the connecting parts of the cooling fan motor connector are free of dirt, water, or other foreign matter.
- Be sure to securely connect the cooling fan motor connector.
