TECHNICAL INSTRUCTIONS
FOR
CUSTOMER SUPPORT PROGRAM 22TE09
HV FLOOR UNDER WIRE HARNESS AND REAR TRACTION MOTOR CABLE
CORROSION
CERTAIN 2021 – 2022 MODEL YEAR SIENNA HYBRID

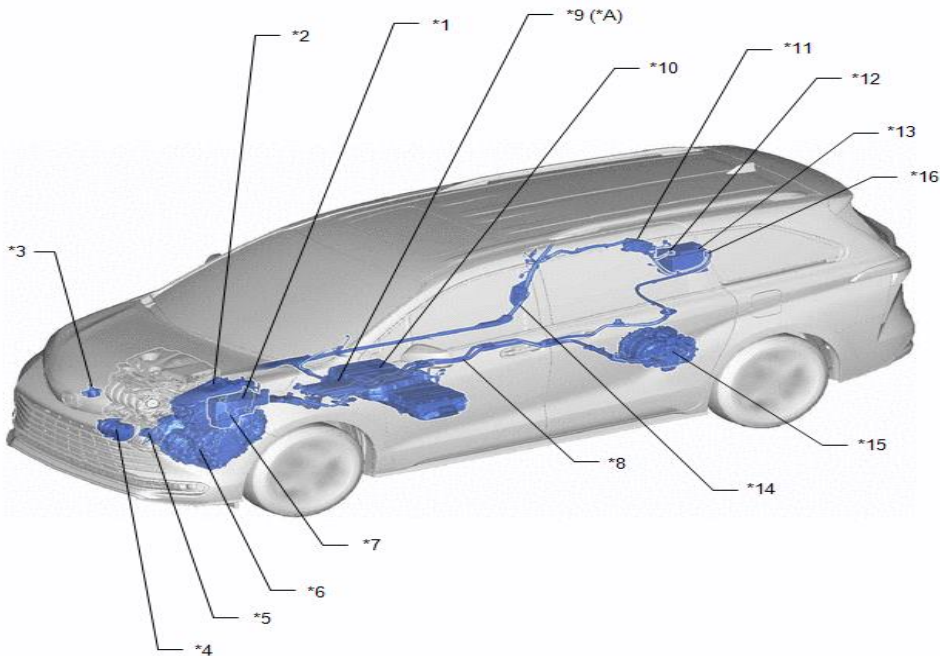
*8	HV FLOOR UNDER WIRE
----	---------------------

Although the HV Floor Under Wire Harness and Rear Traction Motor Cable is covered by Toyota's New Vehicle Limited Warranty for 3 years or 36,000 miles (whichever comes first), we at Toyota care about the customers' ownership experience. Toyota is providing coverage for repairs related to excessive corrosion to the wire harness connections at the Rear Motor Generator. Excessive corrosion can cause AM Radio Static during certain drive cycles or the vehicle may not start.

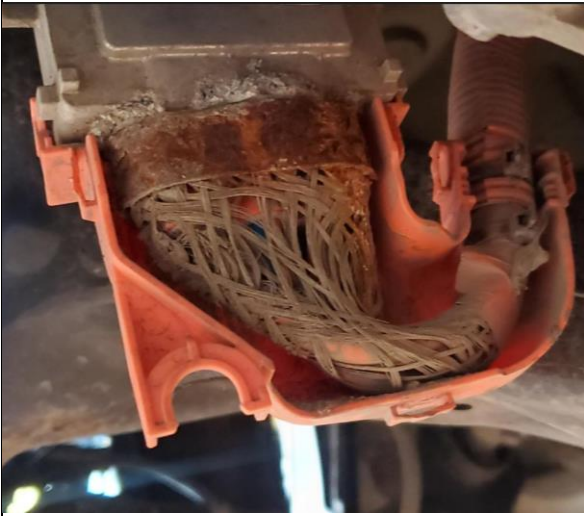
Y6 connector under vehicle at MGR

- 5) Inspect the Y6 connection for corrosion
f) Disconnect the Y6 connector at the MGR and inspect for corrosion, dirt, or debris.

YES – Continue to Section VI.

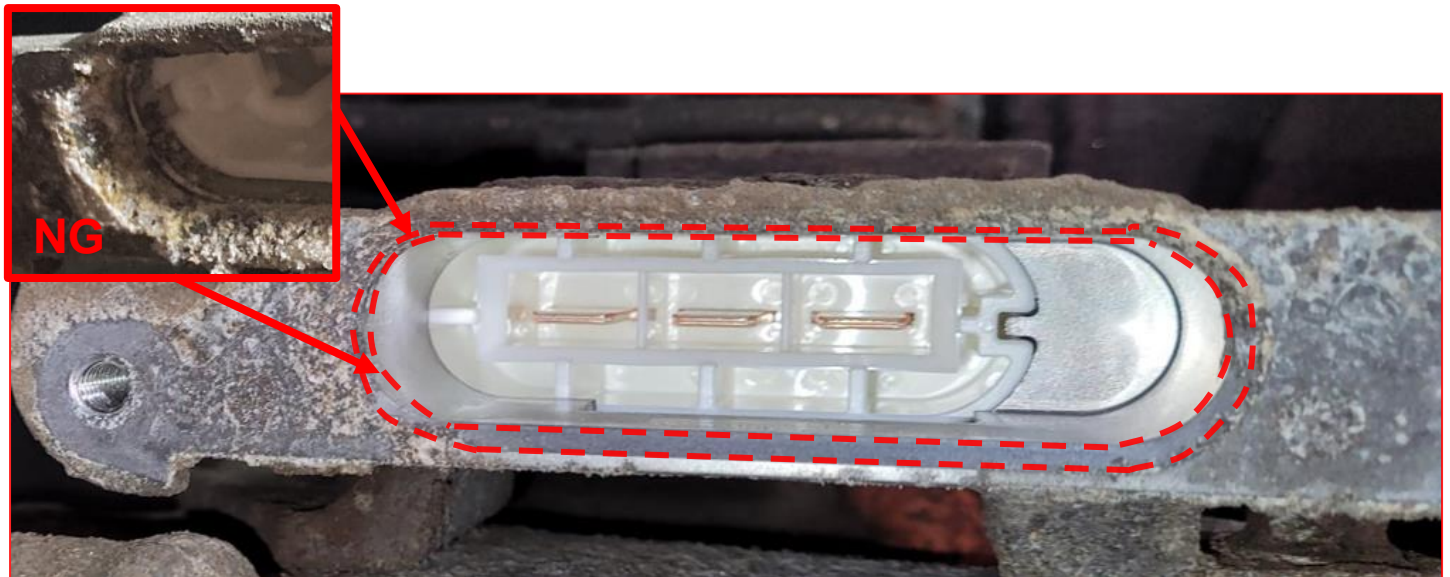
- a) Inspect the chamfer of the MGR connector housing for pitting and corrosion on the sealing surface. Corrosion in this area will cause the seal to leak. Are pitting and corrosion present?

YES – Rear Traction Motor Cable requires replacement continue to Section VI.
