# Technical product information

<b>Topic</b>	Repeated traction control interventions experienced upon reaching 30km/h
<b>Market area</b>	Australia E04 Bentley rest Asia and Australia (6E04),China 723 Volkswagen (Anhui) Automotive CO (6723),China 796 VW Import Comp. Ltd (Vico), Beijing (6796),Germany E02 Bentley rest Europe (6E02),Japan E03 Bentley Japan (6E03),Korea, (South) E08 Bentley South Korea (6E08),United Arab Emirates E06 Bentley Middle East and Africa (6E06),United Kingdom E01 Bentley UK (6E01),United States E05 Bentley USA and rest America (6E05)
<b>Brand</b>	Bentley
<b>Transaction No.</b>	2067579/4
<b>Level</b>	EH
<b>Status</b>	Approval
<b>Release date</b>

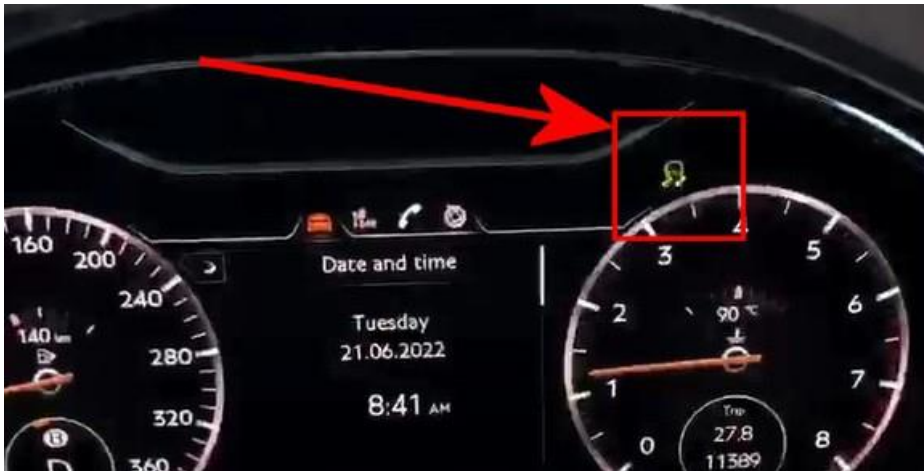
Figure 1

Repeated traction control interventions experienced upon reaching 30km/h (Figure 1)

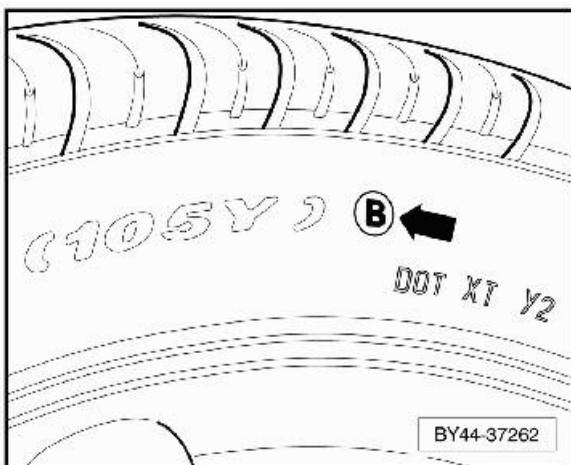
Figure 2

- Confirm the 'B' marking is evident on all tyres (Figure 2)
