Technical product information

| Topic | Front or rear door(s) - Soft close function failure - DTC B122D29 is evident |

Bentayga

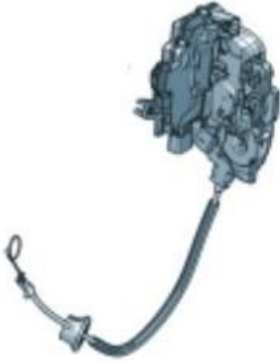
Note: For reference purposes Figure 1 shows an example of a door latch

- Request permission via DISS to replace the applicable door latch **IMPORTANT:** Attach a short video confirming the issue is still evident
- Referring to Rep.Gr 57 (front) or Rep.Gr 58 (rear) replace the applicable door latch
