GROUP	NUMBER	
GENESIS	EV SYSTEMS	24-EV-002G	
	DATE	MODEL(S)	
Technical Service Bulletin	MARCH 2024	GV60 Electric (JW1 EV) G80 Electrified (RG3 EV) GV70 Electrified (JK1a EV)

SUBJECT: INSPECTION/REPLACEMENT OF EV CHARGING PORT INSULATION CAP

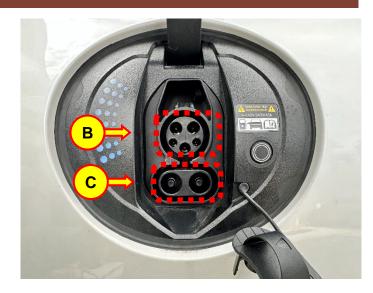
2. Charging Port Inspection for Abnormal Condition:

Inspect both charging areas:

- AC charging terminals (B)
- Quick (DC) charging terminal (C).
- a) Check for any missing, damaged or significantly deteriorated insulation caps.
- b) Check for any foreign matter found inside the port.

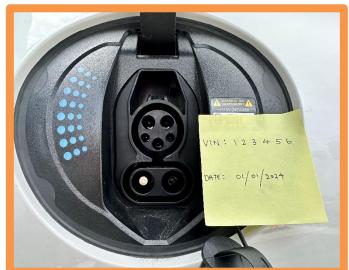
Using STUI, take a photo of the charge port clearly showing the abnormal condition and a piece of paper with the last 6 digits of the VIN and date of the repair.

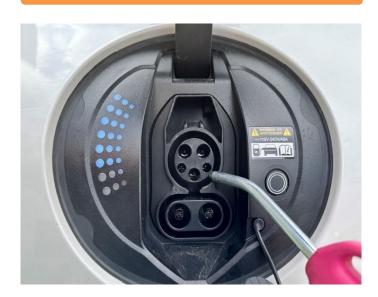
3. When foreign material is observed inside the port:

- Blow out any foreign material with shop air.
- When it is necessary to assist in removing any stubborn dirt that can't be removed by air, spray in a common electrical contact cleaner. Blow out after with shop air again.

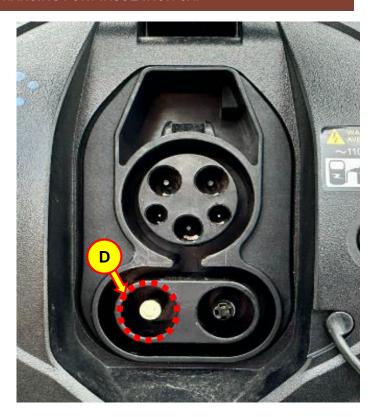
The photo shown at the right is an example of a DC charging insulation cap missing/removed at the left terminal (D).

- Remove the insulation cap if it is damaged, and/or significantly deterioriated.
- Use needle nose pliers and gently grab and pull outwards to remove the cap.

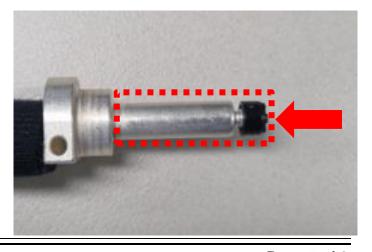
In example at right, insulation cap is in temporarily mounted position.

The DC terminal is shown removed for demonstration purposes only.
