Surround View Camera Intermittent Operation

Models	Model Year	Model Type	VIN Range	Vehicle-Specific Equipment
911	As of 2020 up to 2023	992	N/A	KA6

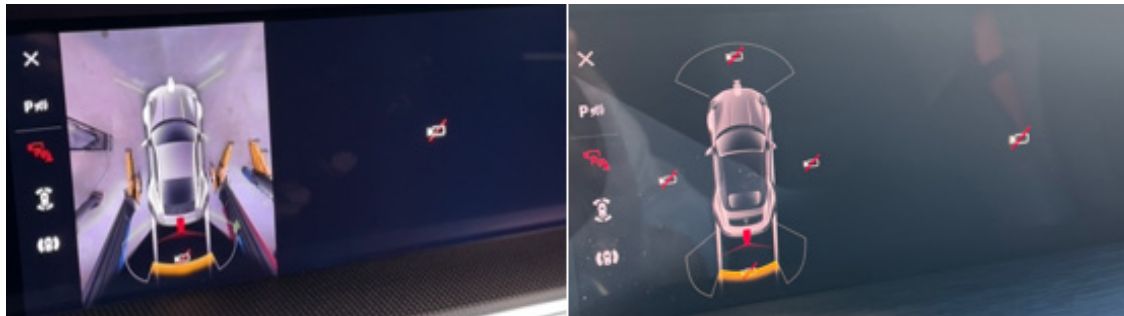
Figure 1

Customer complains of intermittent operation for one or multiple surround view cameras. Failed surround camera(s) appear blank with a crossed-out camera icon.
