992 Windshield Seal Melting/Deteriorating

Vehicles Affected

Models	Model Year	Model Type	VIN Range	Vehicle-Specific Equipment
911	As of 2020 up to 2023	992	N/A	All except VW4 Lightweight Glass

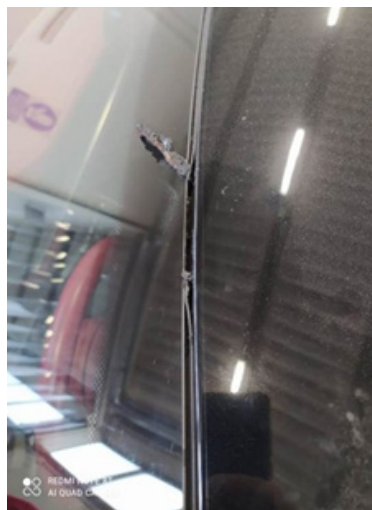
Figure 1

The customer complains of the windshield seal melting or deteriorating.

The observed condition can be the result of a material incompatibility between the windshield seal material and the adhesive used for fixing the windshield.

When these two substances come into contact, a chemical reaction occurs, forming a melted and sticky appearance of the windshield seal. It is important to note that extended exposure to sunlight can make this condition worse.

The service recommendation is to replace the **affected** windshield(s) with a new part number to be defined as soon as possible:

Reference WM 641219 "Removing and Installing Windscreen" and/or WM 648619 "Removing and installing rear window".
