**SERVICE BULLETIN**

**NUMBER:** 15-236-18R

**SUBJECT:** Reprogramming File Availability for Optimization of Harman Gen 3.1 and Gen 3.1α Audio and Navigation Head Units

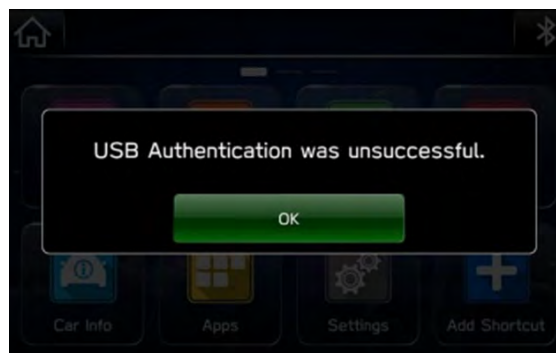
**NOTE:** If an attempt is made to install the wrong “grade” file into the wrong grade head unit (EXAMPLE: “Base” update file into a “Base Plus or Mid” or “High” head unit), the USB Authentication error screen below will be displayed:

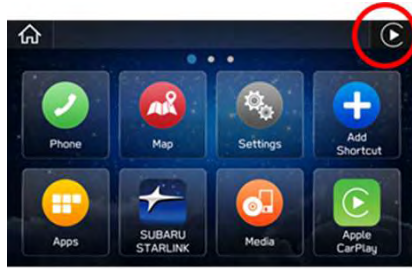
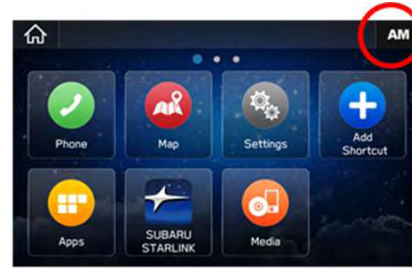
**On Ver. 6.0 and before:**

Music playing via iPhone in CarPlay.

After disconnecting, the music source changes to Radio automatically.

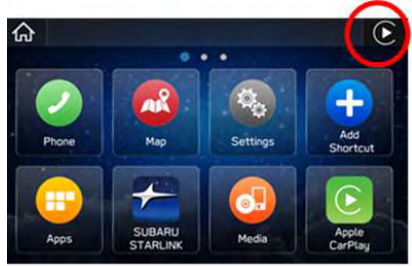
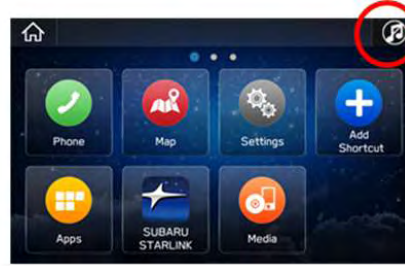
Music playing via iPhone in CarPlay.

After disconnecting, no music source is selected automatically.

If a source of music other than CarPlay has been playing when the iPhone is disconnected, the music source remains same (it is not turned off.)

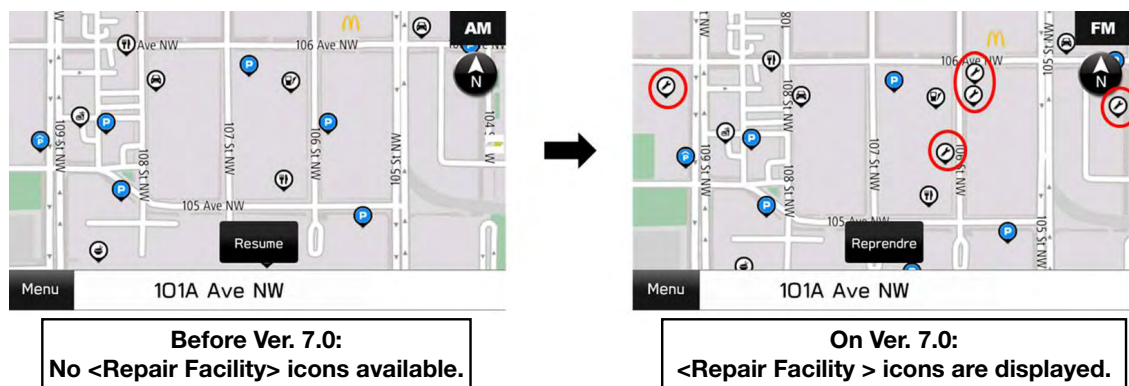
**NOTE 4:** Displaying Repair Facility POI icons:

<Repair Facility> Icons can be displayed in the NAVI Map.

<Repair Facility> Icons can be turned On or OFF by going to: Settings > Navigation > POI Icons.

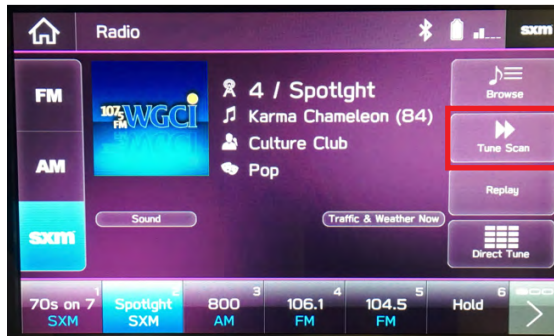
<Scan> previously displayed on SXM screen was changed to <Tune Scan> (a.k.a. SEEK).

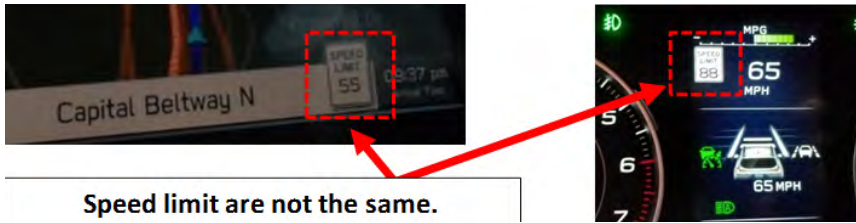
- 12) Mismatch of Speed Limit between Navigation display and the Speed Limit displayed in the Combination Meter Multi-Function Display (MFD).

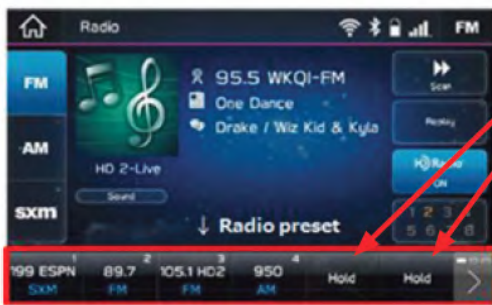
- 1) Station presets are lost. Touch buttons read “Hold”. (Applicable for software versions Rel\_4.18.25.50 (or before)). Included in software version Rel\_U1.18.38.50.
