SERVICE BULLETIN

APPLICABILITY: 2019-23MY Impreza
 2019-23MY Crosstrek (Including Hybrid Model)
 2019-24MY Forester
 2019MY Legacy & Outback
 2019-21MY WRX
 2019-21MY BRZ- Navigation -equipped Models ONLY
 2019-22MY Ascent

NUMBER: 15-256-19R

SUBJECT: FOTA (Firmware Over-The-Air) Reprogramming
 Procedure to Optimize Harman Gen 3.1 Audio / Navigation Units

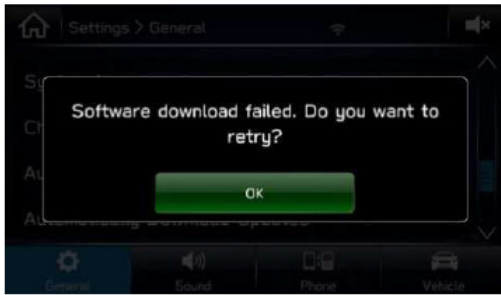
1.5.6) If the H/U display shows “Software download failed. Do you want to retry?”, there is possibility the H/U is not receiving the clock information correctly.

1.5.7) Move the vehicle to a location where the Navi can receive GPS signal or connect to a smartphone via Bluetooth. Ensure that transferring of phonebook data has been approved on the phone. (To review clock setting procedures, refer to Step 1 above.)
