## SERVICE BULLETIN

**APPLICABILITY:** 2016-18MY Crosstrek  
 2016-18MY Forester  
 2016-18MY Impreza  
 2016-18MY Legacy & Outback  
 2017-18MY WRX

**NUMBER:** 15-312-23R

**SUBJECT:** Data Control Module (DCM)  
 Dark Current Diagnosis

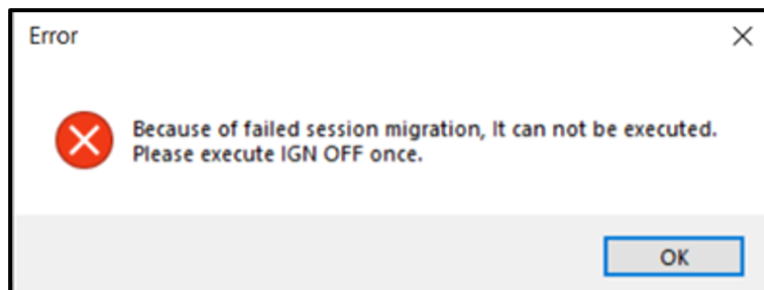
4. Click the Mode Check button to ensure the Current Mode is Factory Mode.
  - A. If any mode is displayed other than Factory, attempt the Mode Setting again to see if it is successful on a second attempt.
  - B. If, after multiple Mode Setting attempts, the Current Mode is not Factory Mode or the error message below is displayed, then the DCM must be replaced to correct the excessive parasitic draw.
