TECHNICAL SERVICE BULLETIN

2.5L FHEV - 4WD - Grinding/Rubbing Noise While Braking At Or Below 10 MPH (16 Km/H) From The Front Of The Vehicle

24-2078

18 March
2024

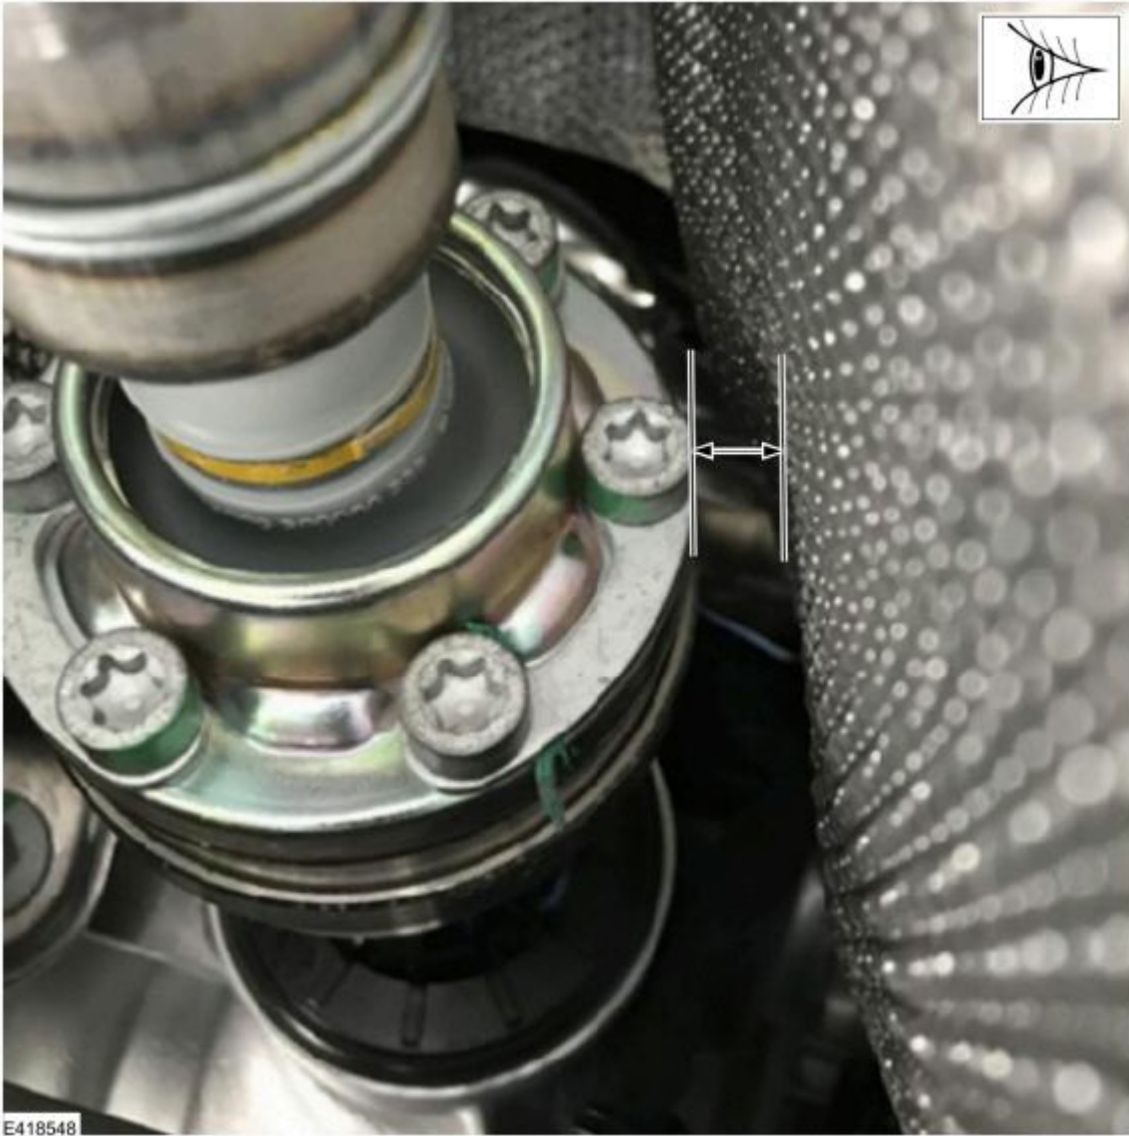
3. Inspect if the heat shield and the driveshaft have a gap below 1 in. (25.4 mm) or if there are any rubbing marks on the driveshaft and/or the fasteners. (Figures 1-2)

Figure 1 - Example of inadequate gap between the driveshaft and the heat shield

4. If the gap is below 1 in. (25.4 mm) or if there are any rubbing marks on the driveshaft and/or the fasteners, position the heat shield away from the driveshaft. (Figure 3)

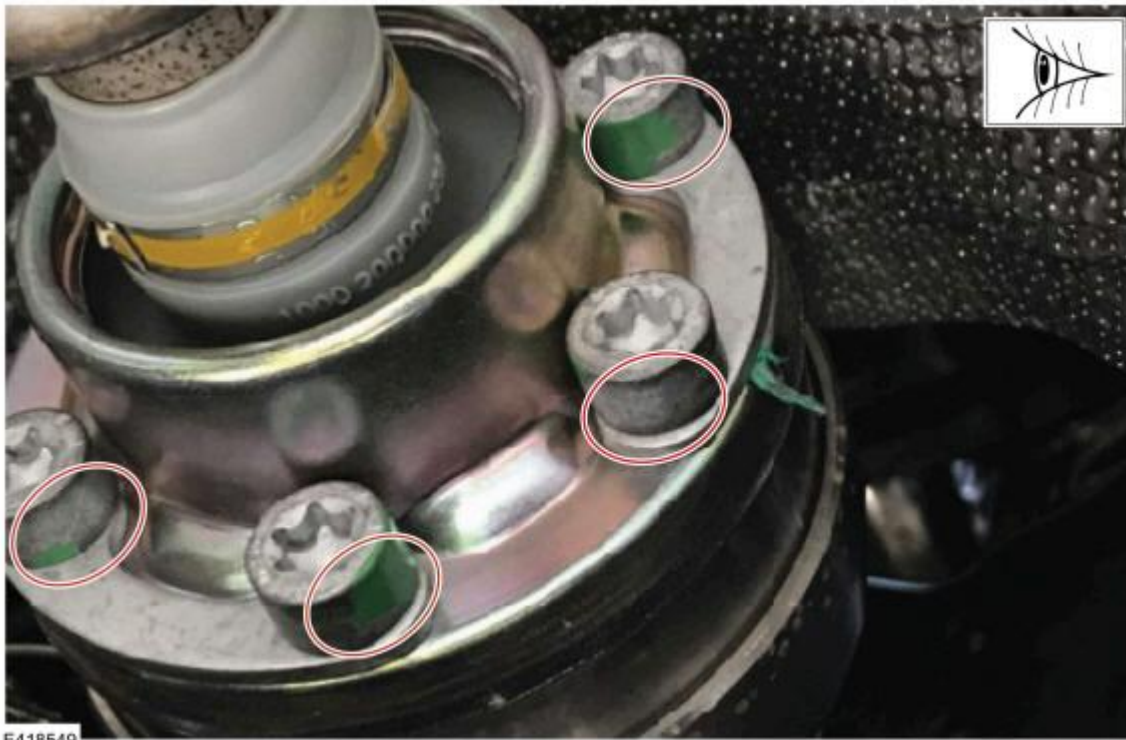
Figure 2 - Example of rubbing marks on the driveshaft fasteners
