Macan /Cayenne – Front Window Motor Without Function

Vehicles Affected

Models	Model Year	Model Type	VIN Range	Vehicle-Specific Equipment
Macan	2020 - 2023	95B	N/A	N/A
Cayenne	2020 - 2023	9YA, 9YB	N/A	N/A

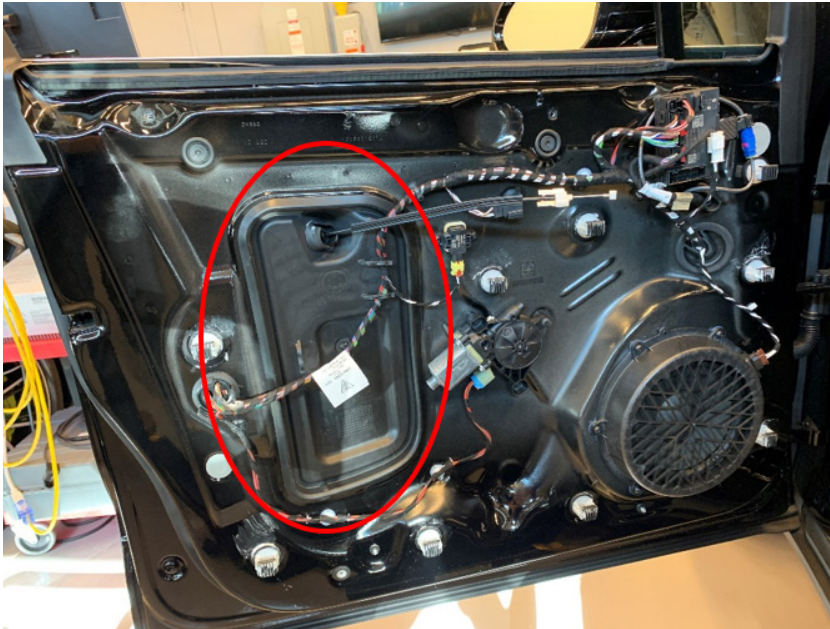
Figure1

5. Remove the large rubber cover towards the rear of the door to gain access to the rear part of the window regulator mechanism.

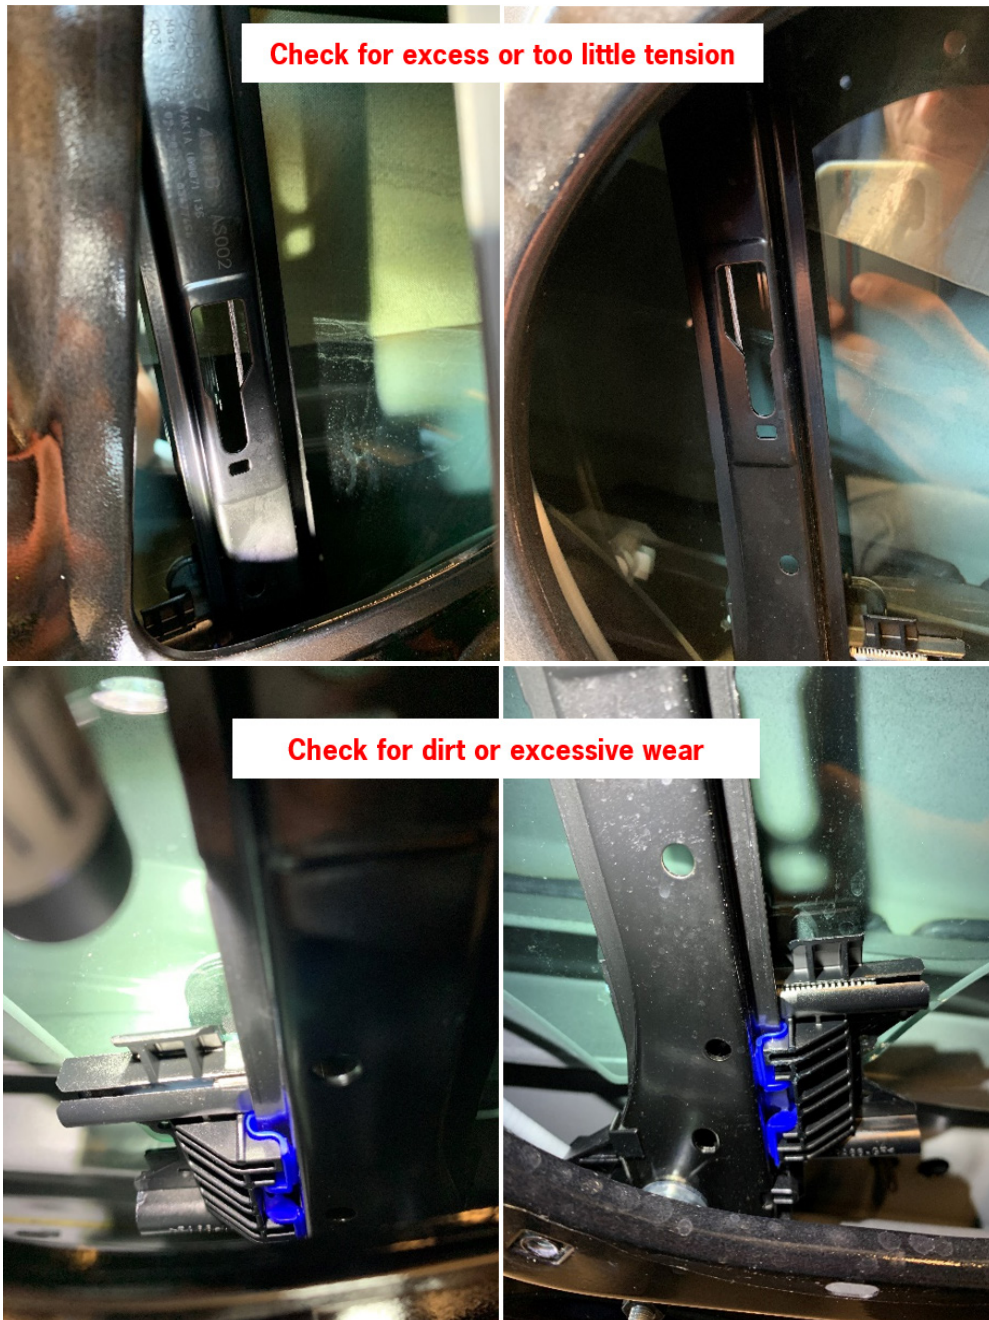
Figure 2

8. Inspect the window regulator mechanism and the window motor for excess tension, dirt, or wear. Ensure that the window regulator mechanism is easy to move. Clean the window regulator mechanism as needed.

9. If there are no faults in the window guide seals or the window regulator mechanism, the window regulator motor must be replaced per WM 645419 – *Removing and installing window regulator motor.*
10. Please completely document the findings to all above steps in the PCSS job.
