Symptom - Rattling Noises from Around the Rear Axle: Checking Engine Mount (SY 183/21)

Model Line: **911 (992)**

Model Year: **As of 2020 up to 2024**

Concerns: **Rear engine mount**

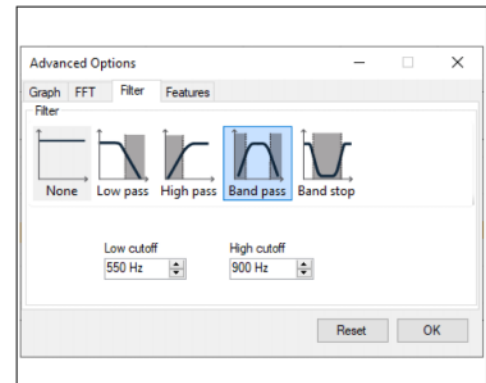
Frequency filter

- 6.3 Open the "Record and Analyse" tab.
 - 6.4 Switch view from "Frequency" to "Time Domain".
 - 6.5 Set filter to 550 Hz–900 Hz if not already done. ⇒ *Frequency filter*

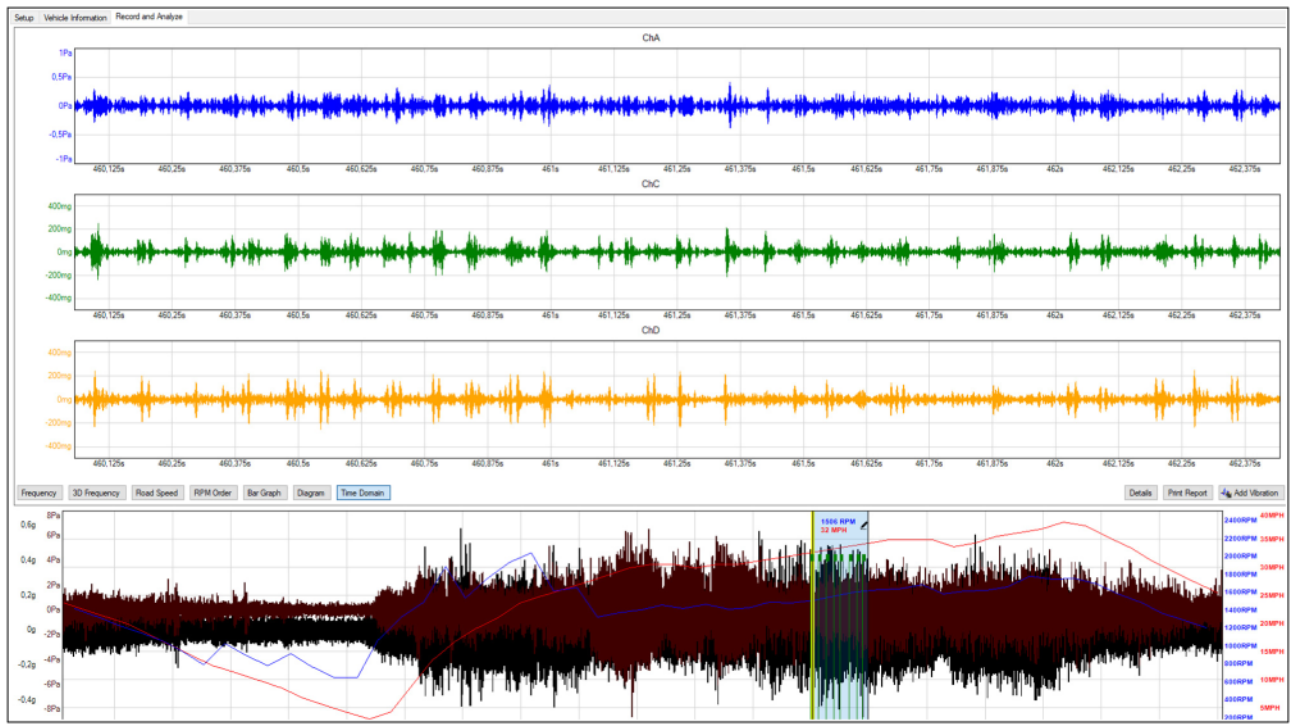
Sample measurement

Assessment		Action
(✓)	The noise can be attributed to the engine mounts.	<p>Using empirical values and, if necessary, a comparison vehicle with dynamic engine mounts, estimate whether these are unusually strong noises.</p> <p>If the noise is rated as "normal", replacing the engine mounts would not make any improvement. If the noise is rated as "not normal", replacing the engine mounts can make an improvement.</p> <p>If necessary, continue with: ⇒ <i>Technical Information '440519 Replacing engine mounts'</i></p>
(✗)	The noise cannot be attributed to the engine mounts.	<p>The engine mounts are not the cause of the noise.</p> <p>If necessary, contact Technical Support in order to agree on how to proceed.</p> <p>End of test.</p> <p>Continue with: Step ⇒ 7.</p>

- 2 Replace engine mounts.
⇒ *Workshop Manual '103519 Removing and installing engine mount'*
