WRC4 - Checking Filler Flap/Charge Port Door and Rework if Necessary (Stop Delivery)

Model Line: Panamera E-Hybrid (YAA / YAB)

Model Year: As of 2024 up to 2025

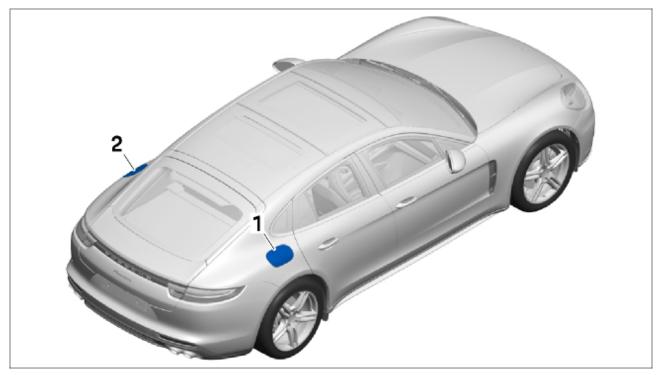
Installation position of filler flap and charge port door

- 1 Filler flap
- 2 Charge port door
