WRC5 - Checking Main Wire Harness in Luggage Compartment and Rework if Necessary (Stop Delivery)

Vehicle Type: **Panamera (YAA / YAB)**

Model Year: **As of 2024 up to 2025**

Concerns: **Main wire harness in luggage compartment**

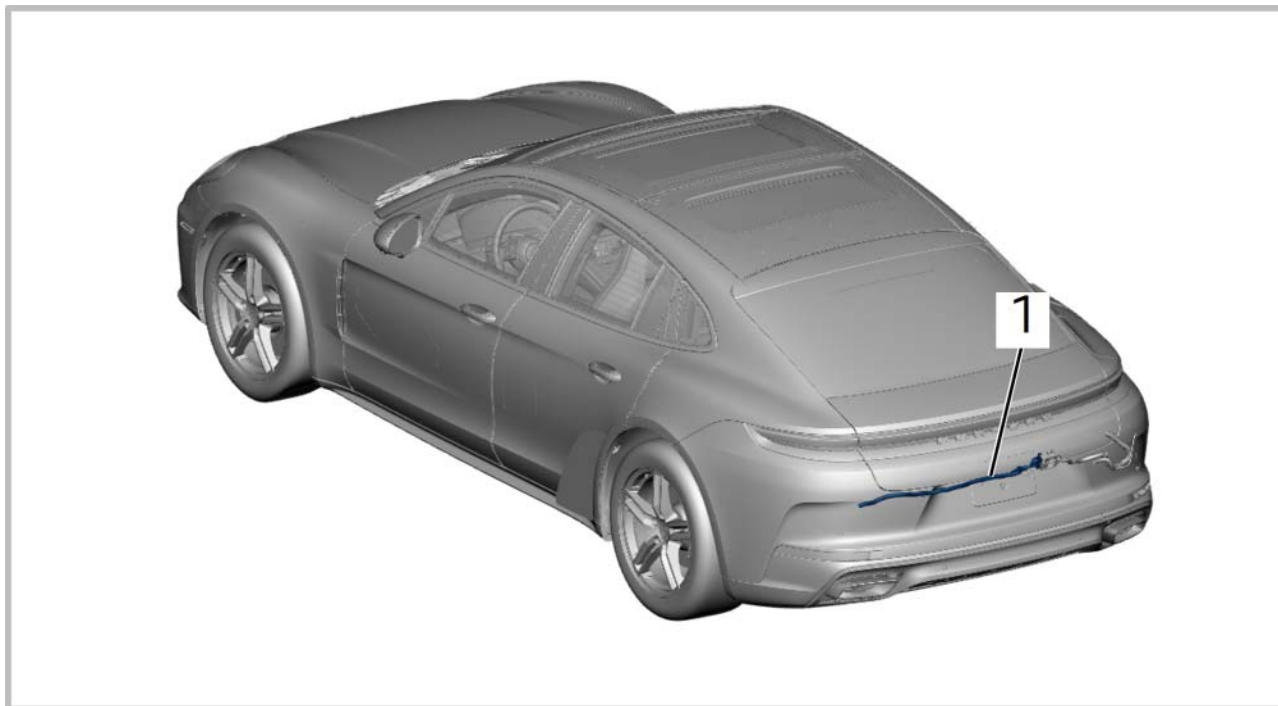
Installation position of main wire harness in luggage compartment

Cause: **There is a possibility that, due to a process error during assembly, the main wire harness in the luggage compartment was not routed according to specifications in the affected vehicles.**

If this is the case, damage to the main wire harness cannot be ruled out.

1 – Main wire harness in luggage compartment (**check and rework if necessary**)

Action: Before delivery, check the main wire harness in the luggage compartment and rework if necessary.

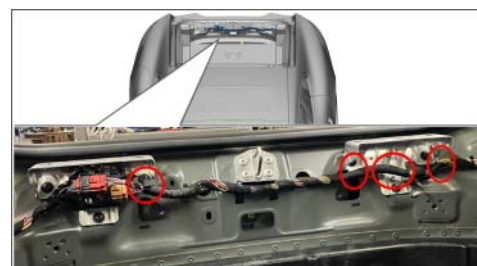
Checking main wire harness in luggage compartment

2.2 Then check the cables for damage at marked points ⇒ *Checking main wire harness in luggage compartment* in the area of the sheet metal edges.

- If no, or only slight, traces of chafing are visible on the wire harness, wrap the wire harness 2x at the marked points with fabric adhesive tape ⇒ *Wrapping main wire harness in luggage compartment*. Then complete the vehicle again. Continue with Step 4.

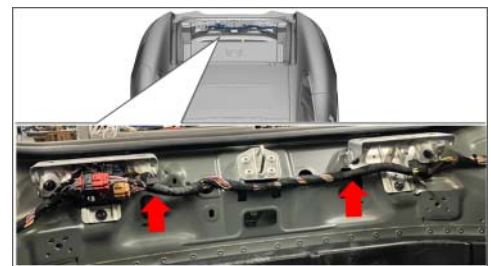
Constriction for main wire harness

Due to the increase in the cross-section at this point, the luggage compartment trim panel may squeeze the wire harness. In this case, disconnect the line at a different location and reroute it up to the plug. These additional activities can be invoiced using a reimbursement claim for the original campaign claim. Document graphically and/or attach corresponding damage in the PQIS line.

Make sure that the line is not repaired at tight points ⇒ *Constriction for main wire harness* -Arrows- with a crimp connection.
